Attachment A

Photographs of Mission Creek
Sidecast Areas

Access Road Maintenance
Project- Tunnel Trail Area,
1/29/2020 and 1/31/2020

Sidecast Material – Volume Estimate,
Mission Creek Access Road,
5/7/2020

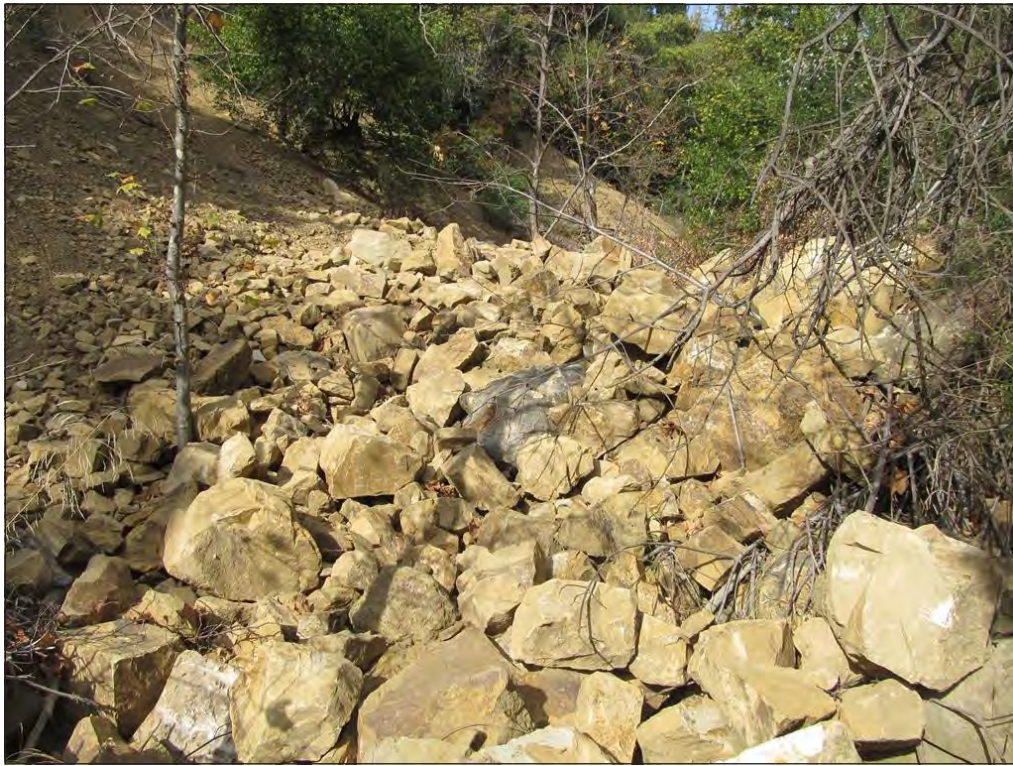
Photo 1. Example of sidecast in Mission Creek.

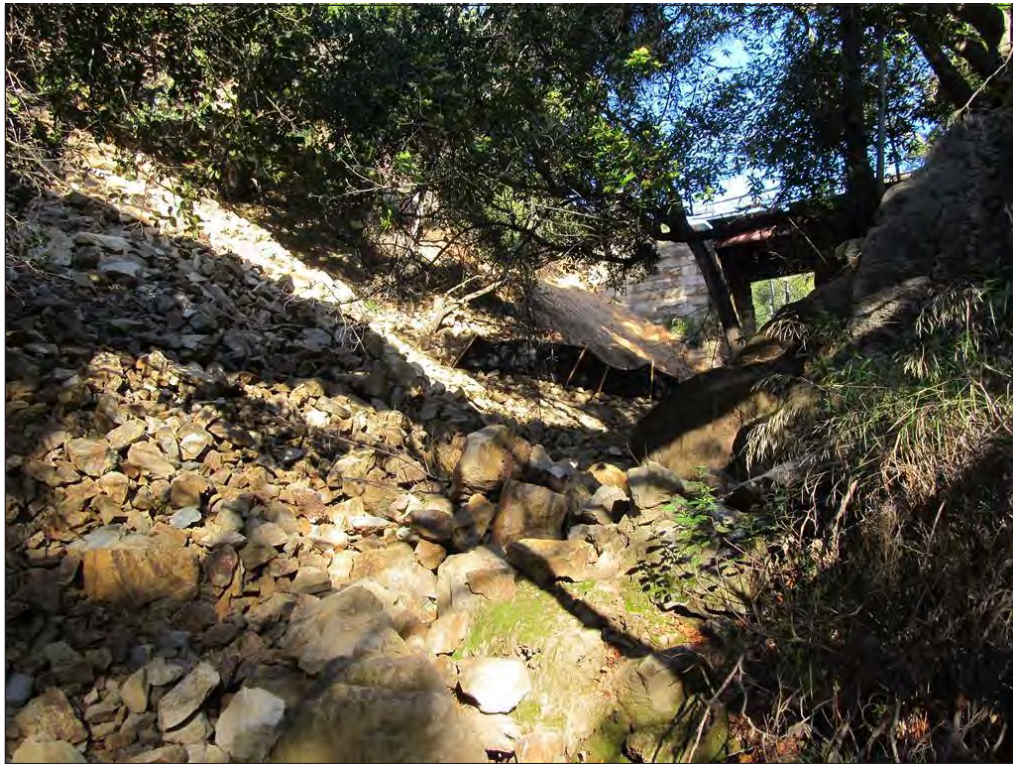
Photo 2. Looking upstream at Creek Site 2 in Mission Creek.

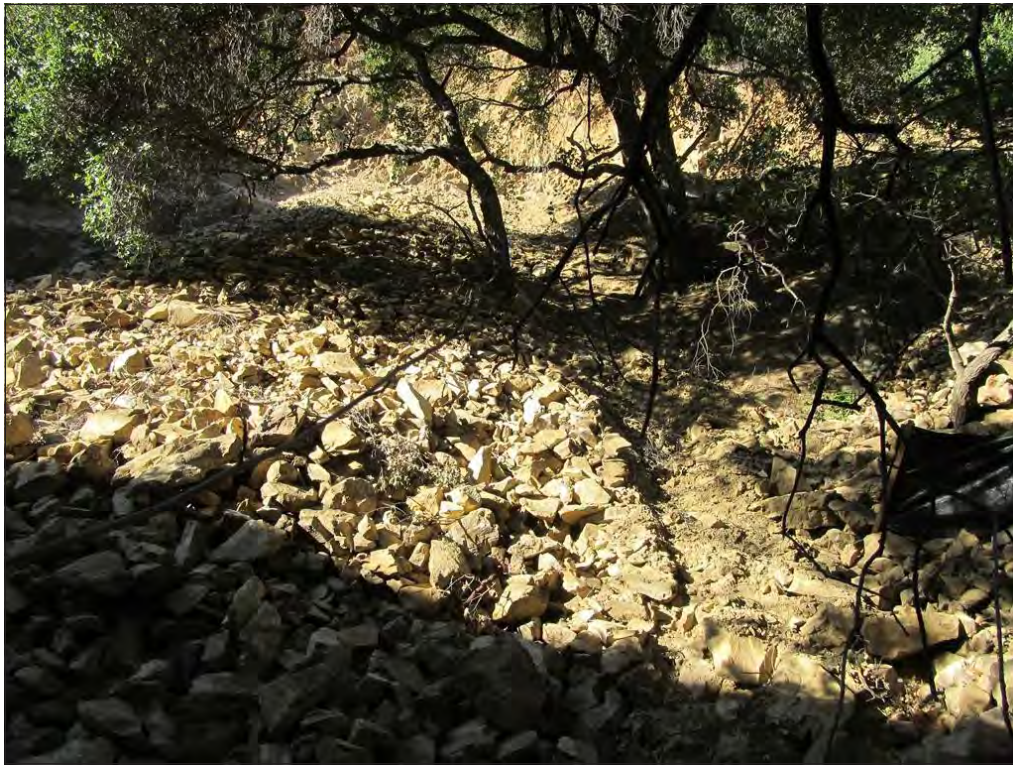
Photo 3. Looking downstream in Mission Creek from Creek Site 2.

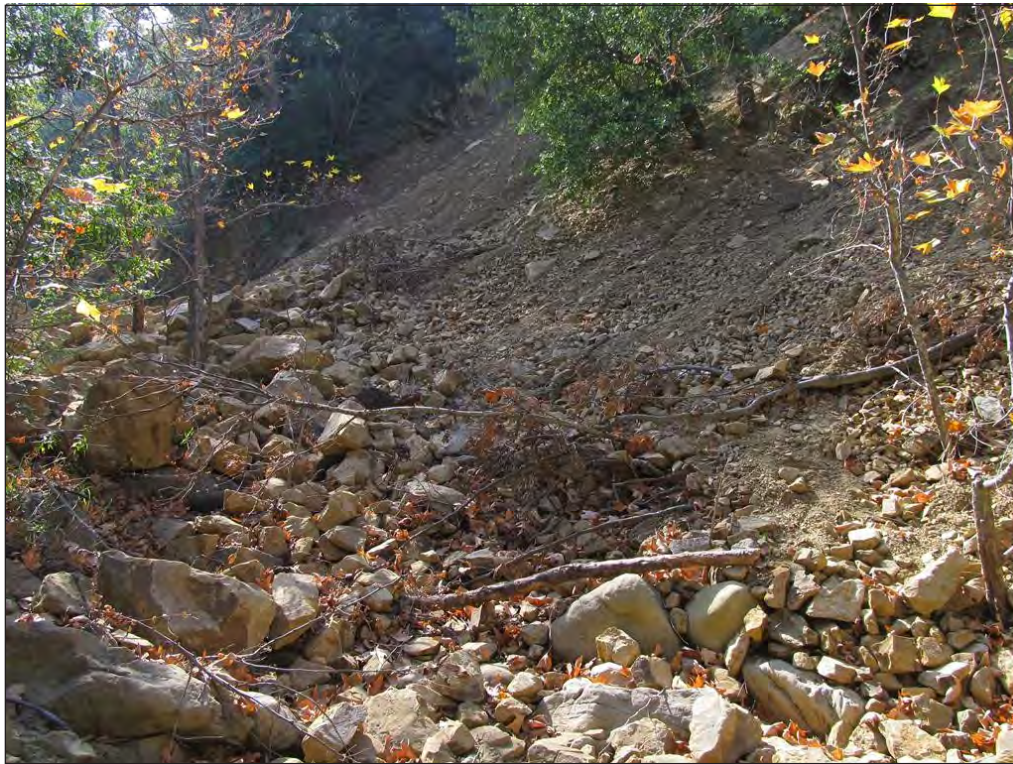
Photo 4. Looking downstream in Mission Creek at Creek Site 3.

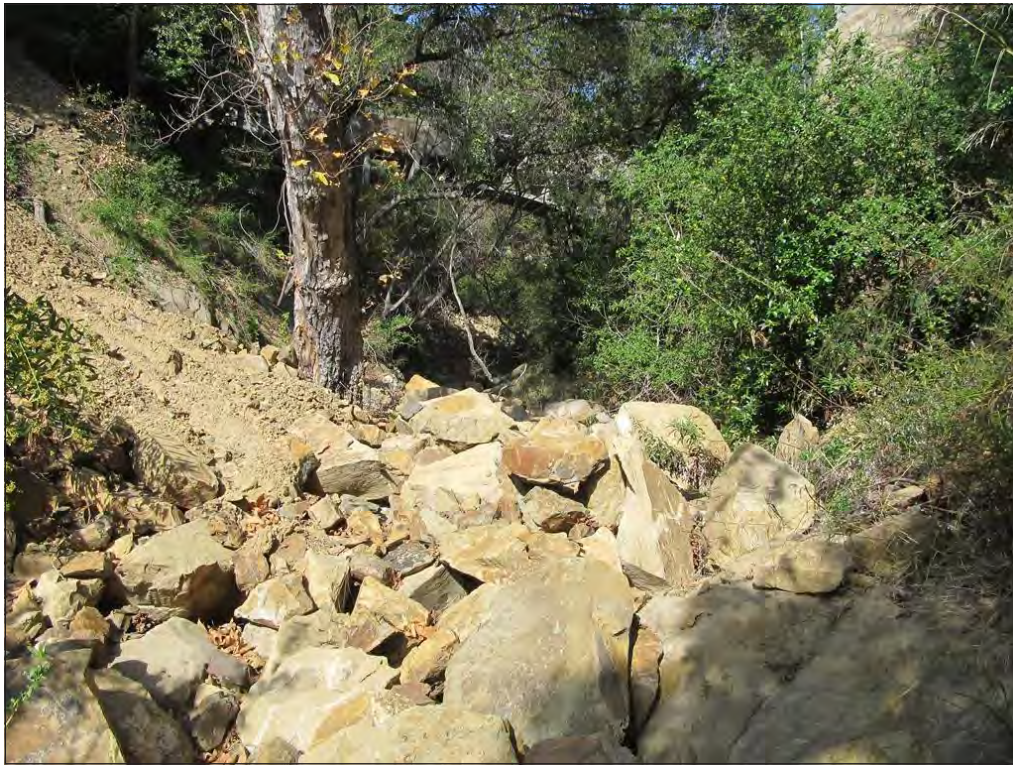
Photo 5. Looking upstream in Mission Creek at Creek Site 4.

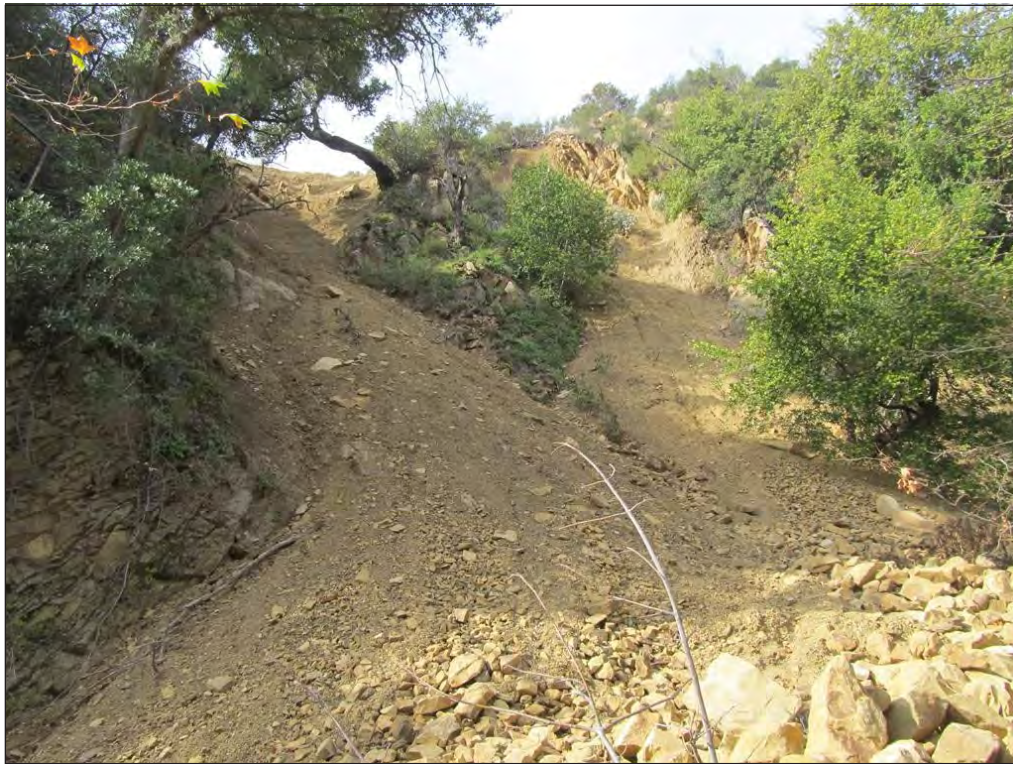
Photo 6. Looking up from Mission Creek toward the road at Creek Site 4.

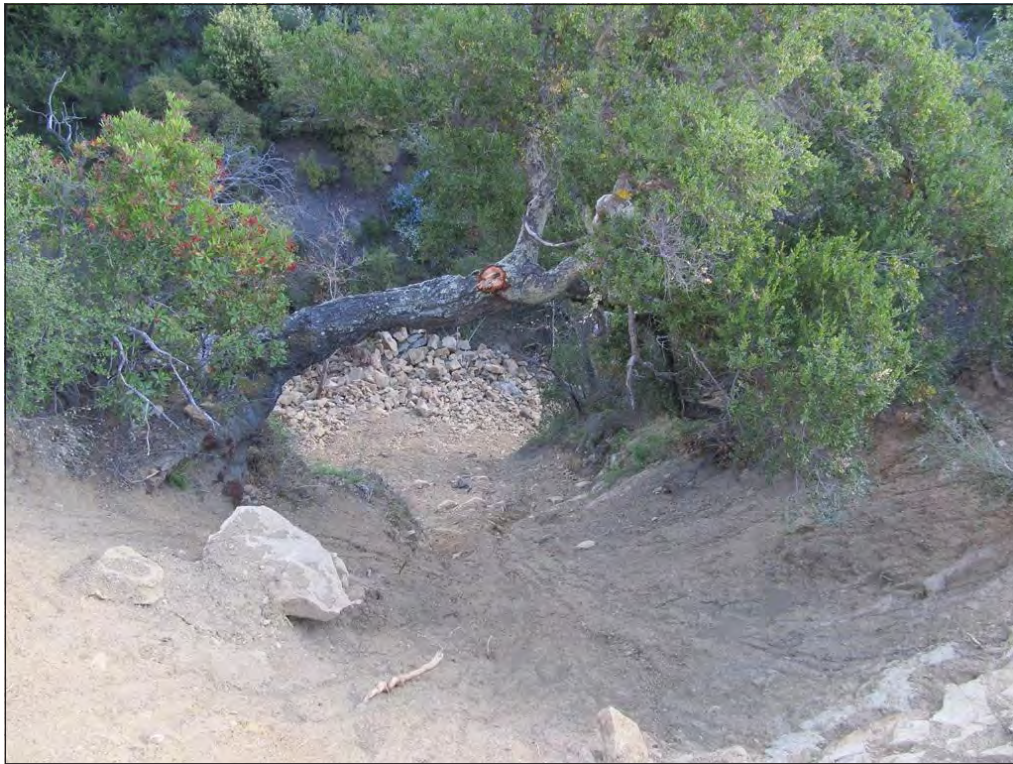
Photo 7. View into Mission Creek from the road at Creek Site 4.

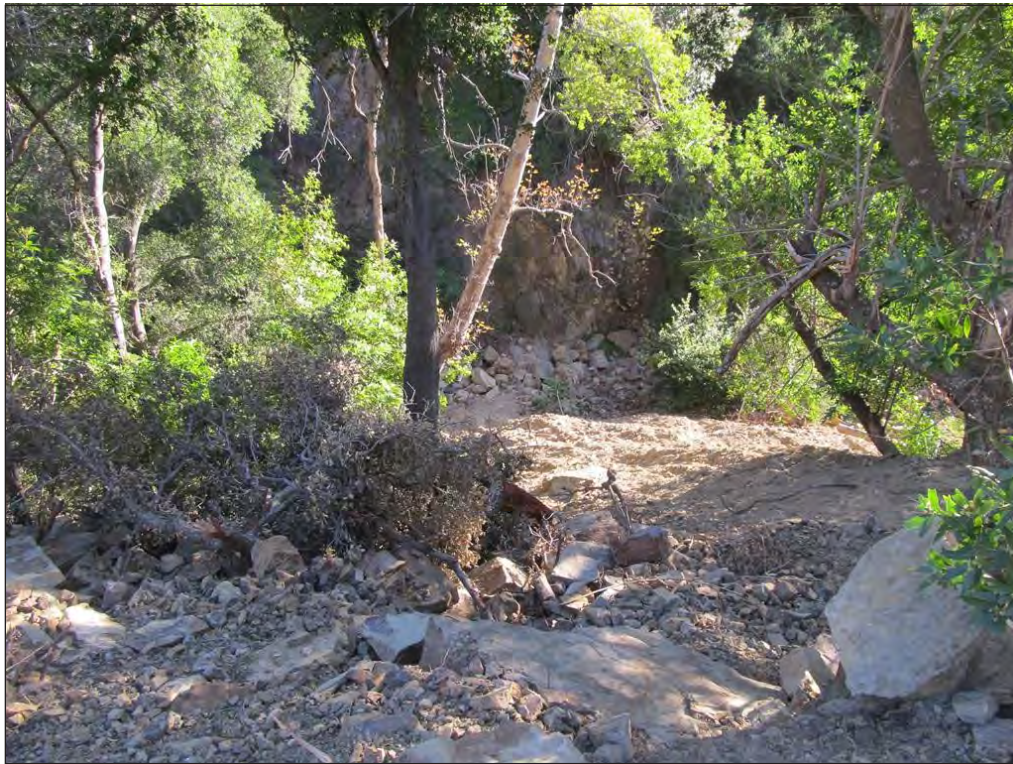
Photo 8. View into Mission Creek from the road at Creek Site 3.

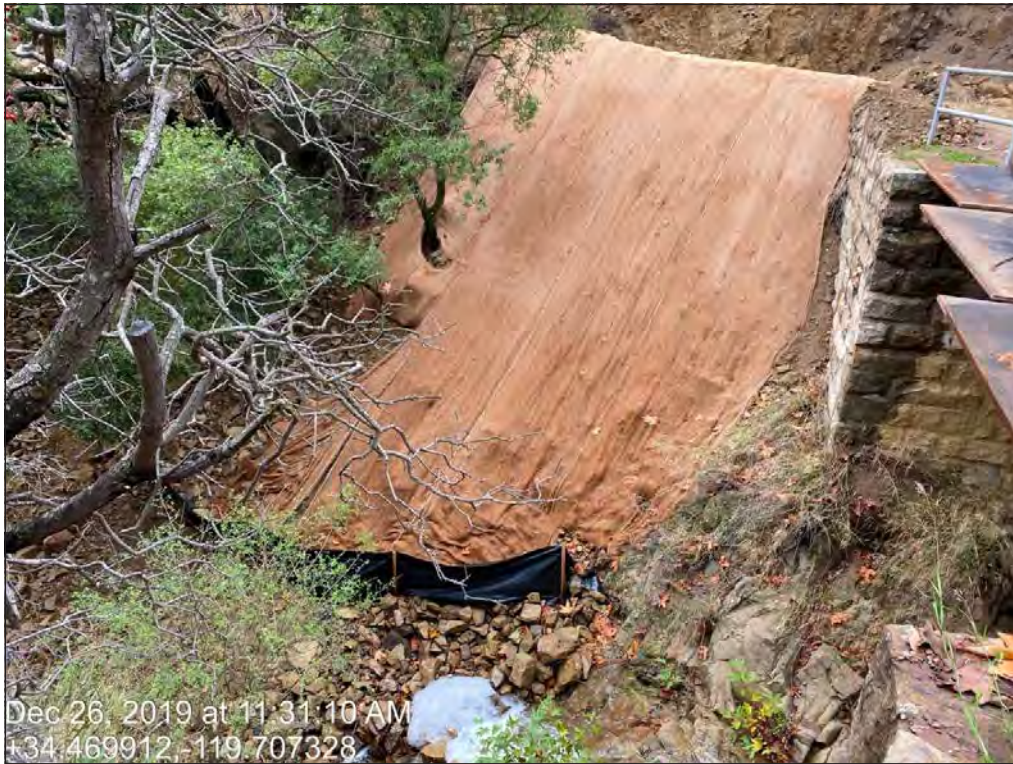
Photo 9. Erosion control matting and silt fence at Creek Site 2.

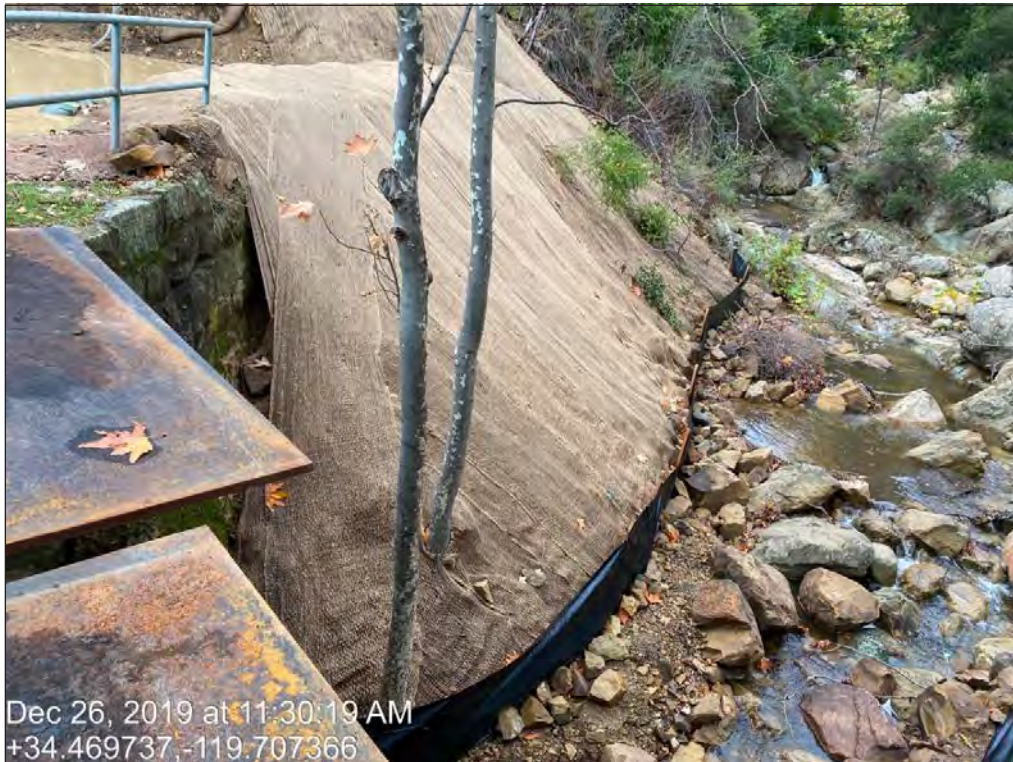
Photo 10. Erosion control matting and silt fence at Creek Site 1.

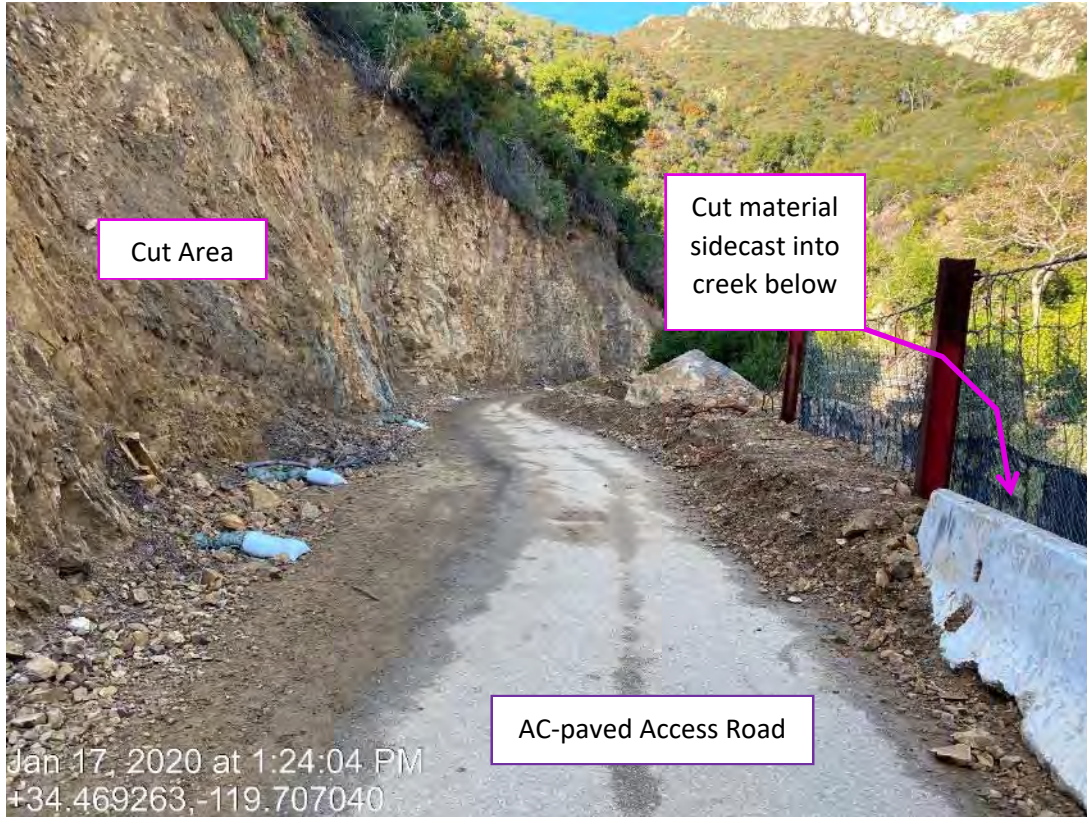
Photo 1: Cut face, AC-paved road, looking northwest.

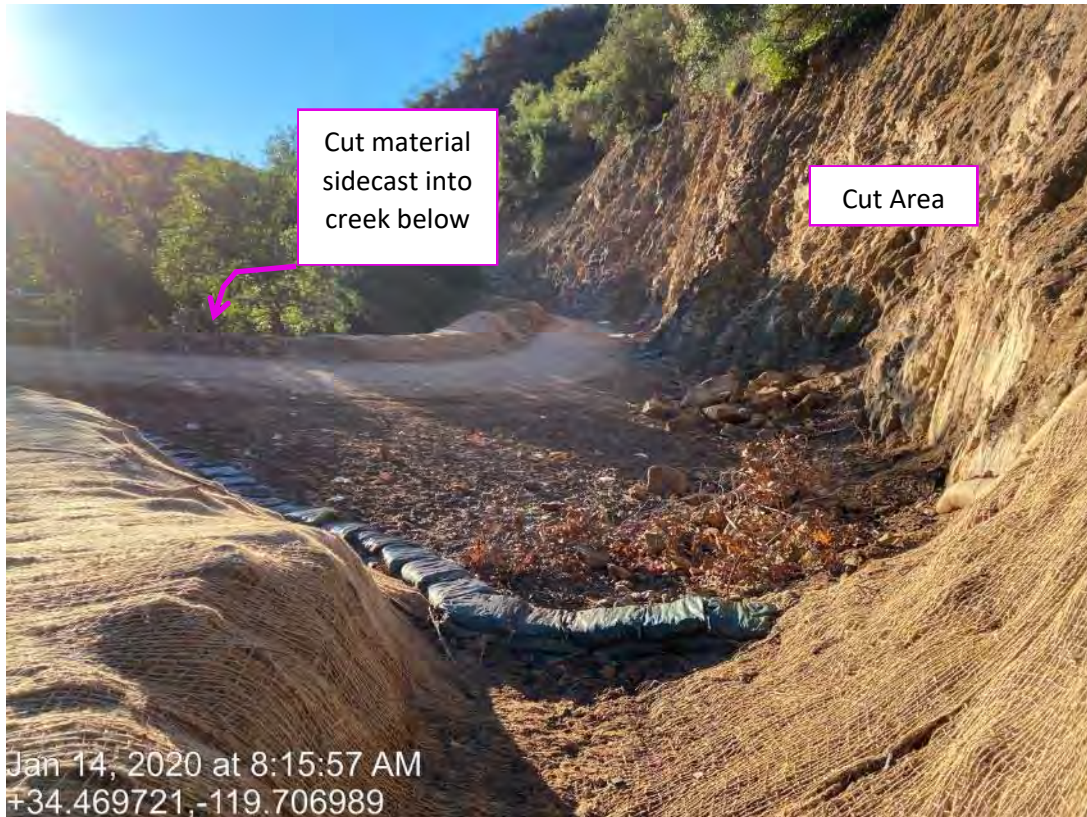
Photo 2: Cut face near bridge, looking southeast.

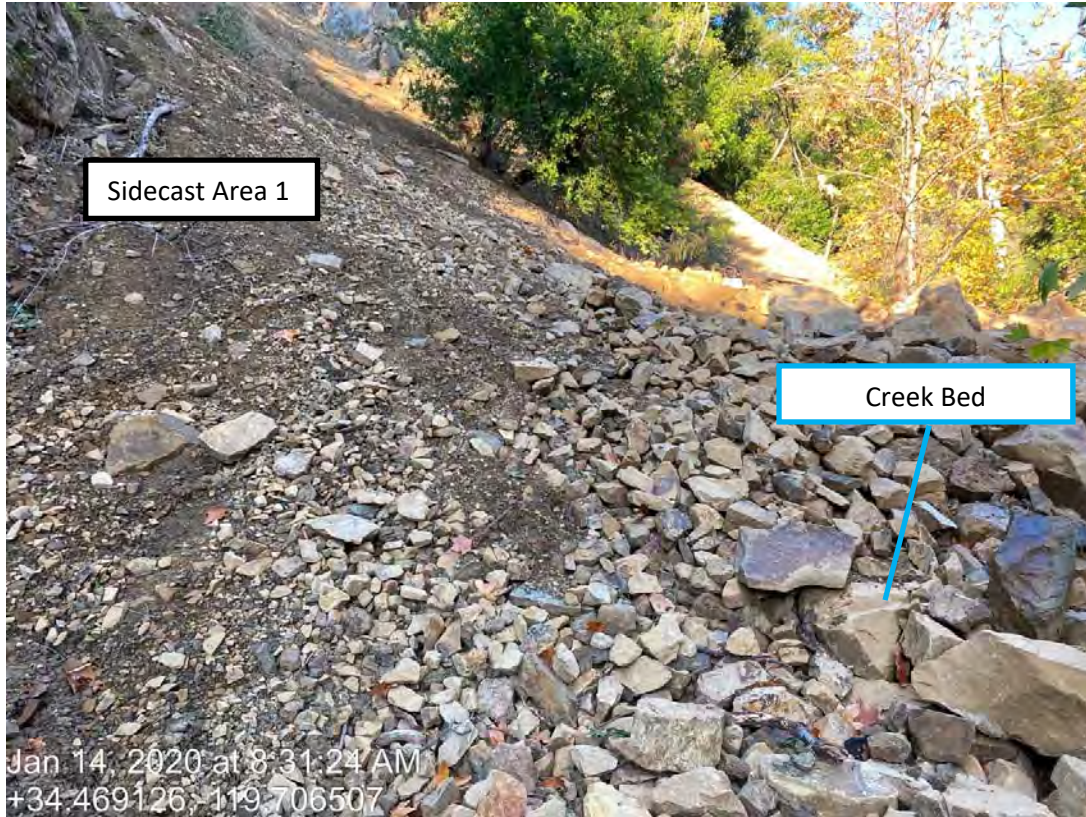
Photo 3: Sidecast Area 1.

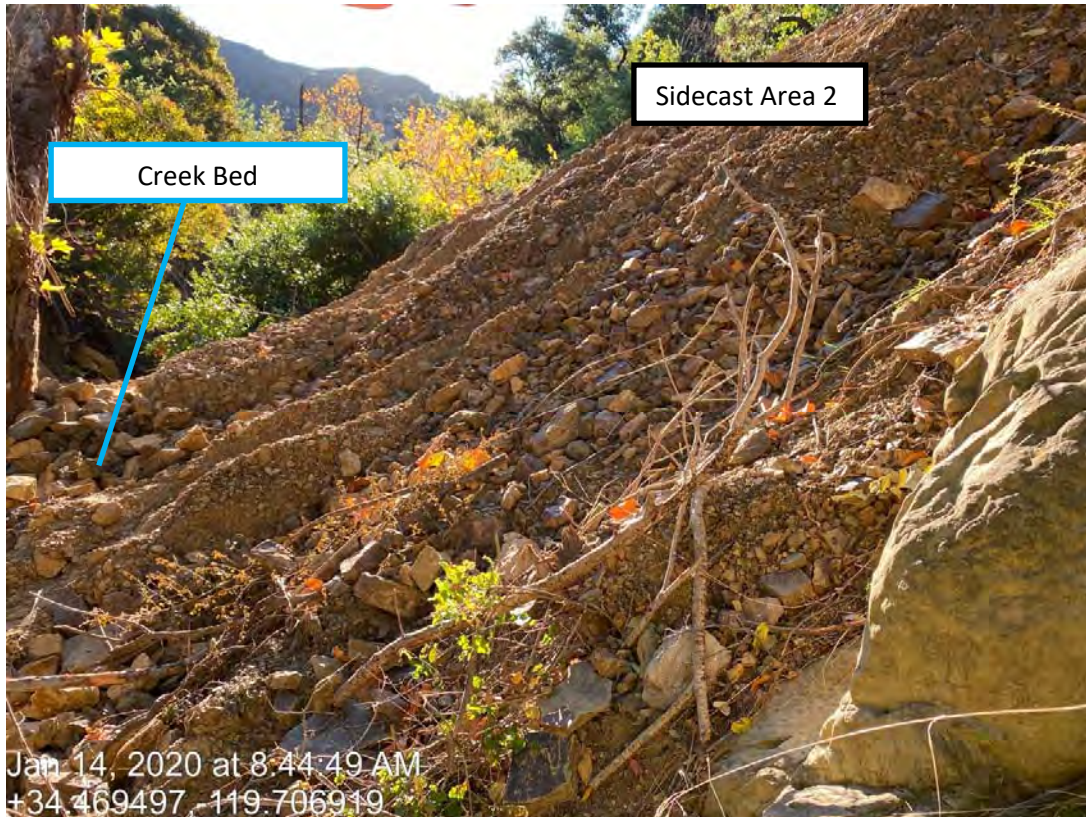
Photo 4: Sidecast Area 2.

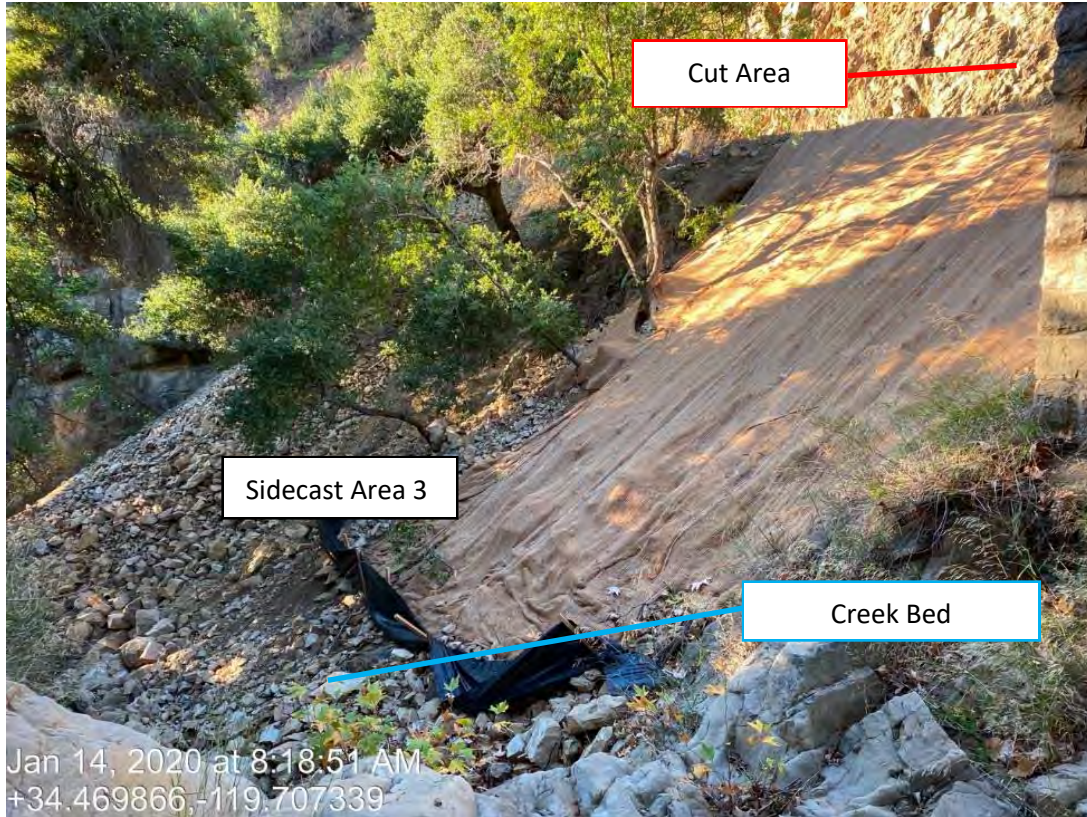
Photo 5: Sidecast Area 3.

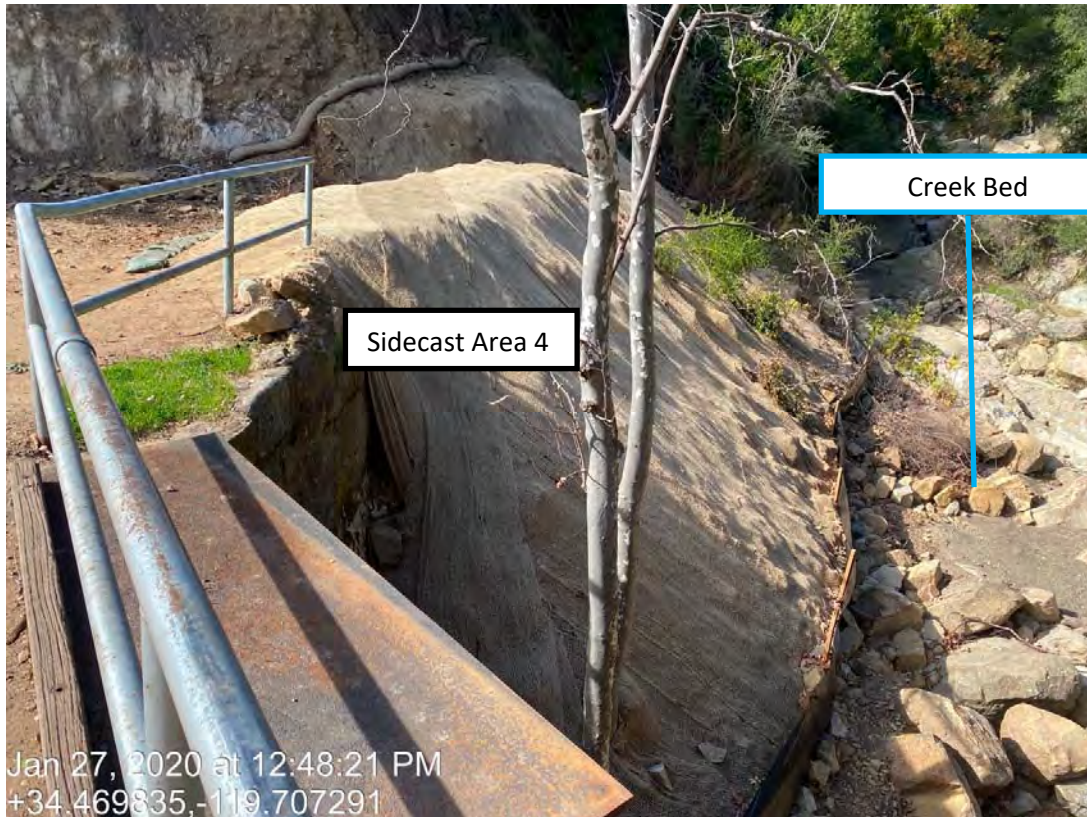
Photo 6: Sidecast Area 4.

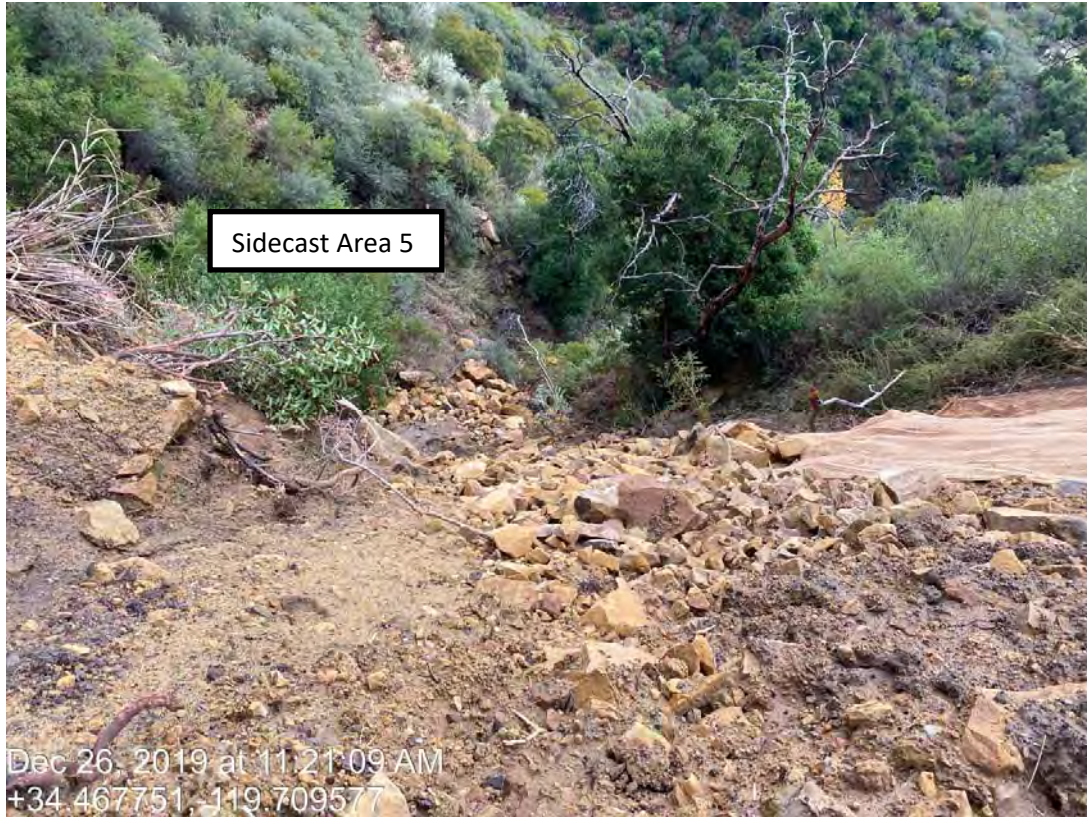
Photo 1: Sidecast Area 5.

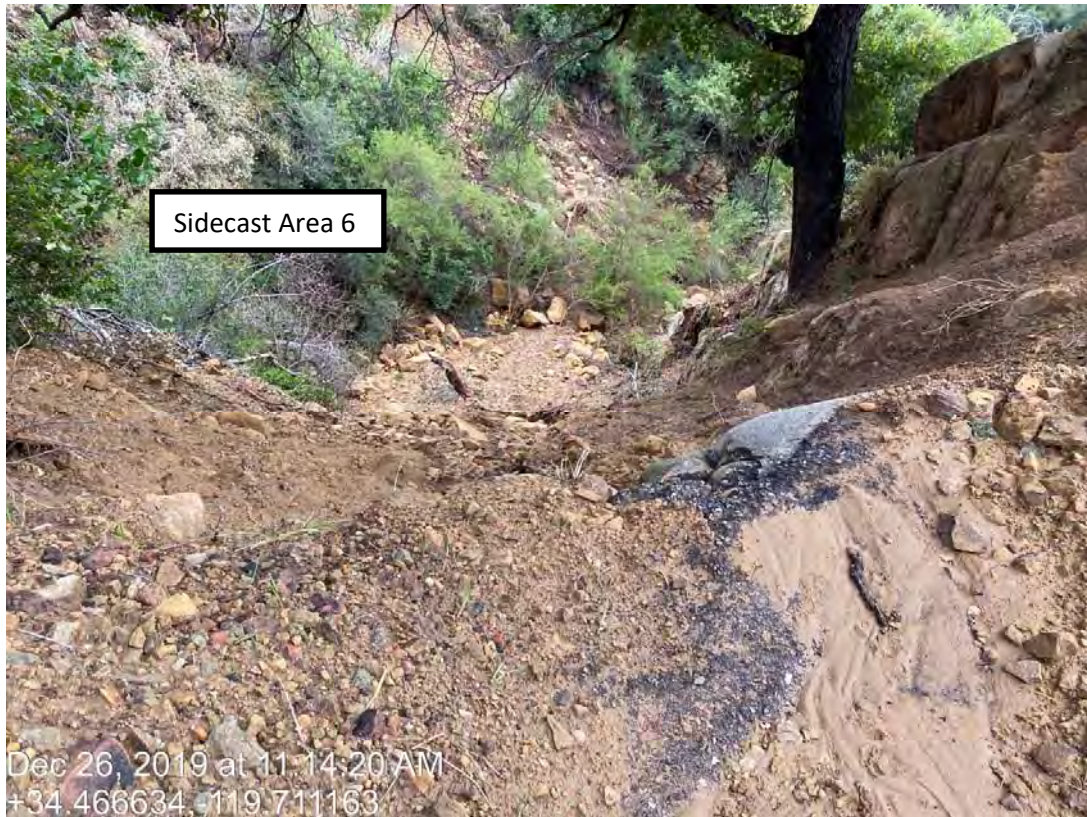
Photo 2: Sidecast Area 6.

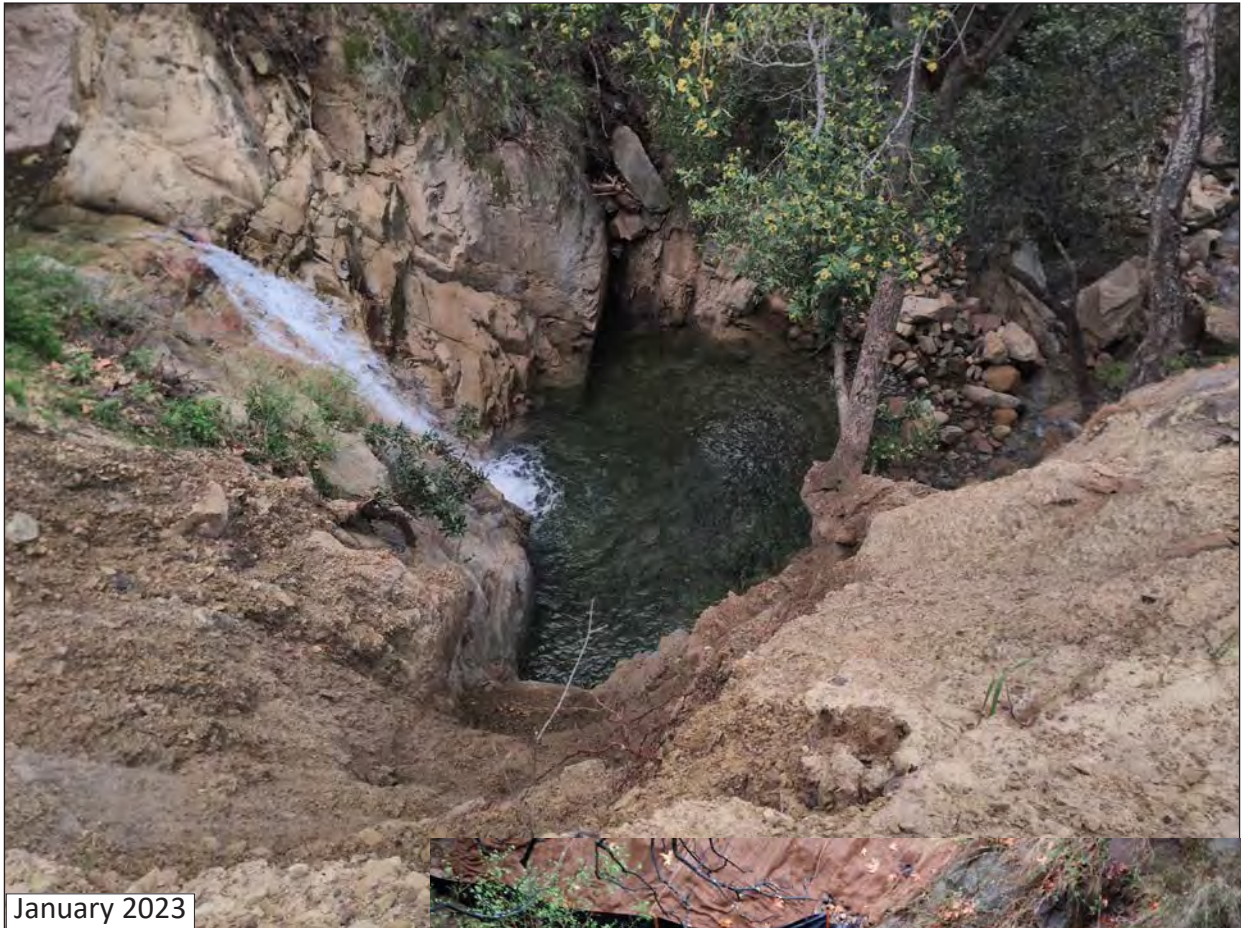
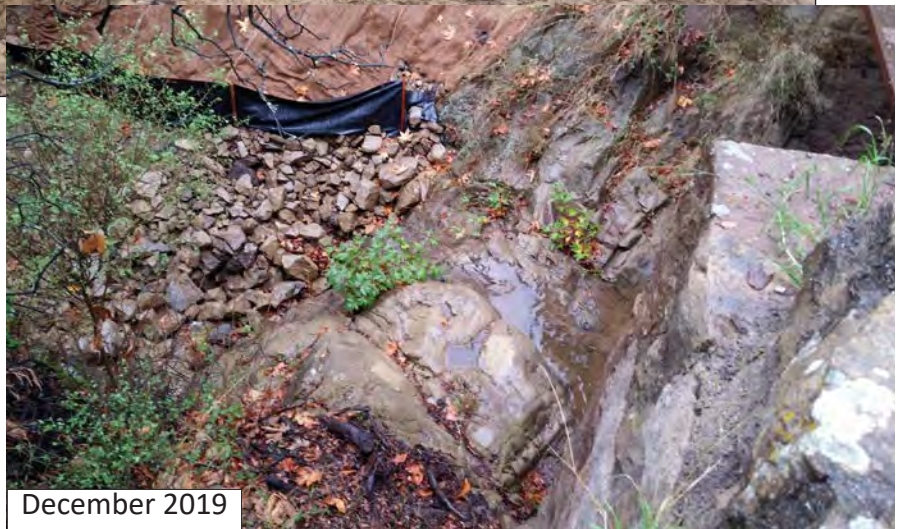
Photograph 1a-b. Creek Site 2, Mission Creek plunge Pool below bridge.

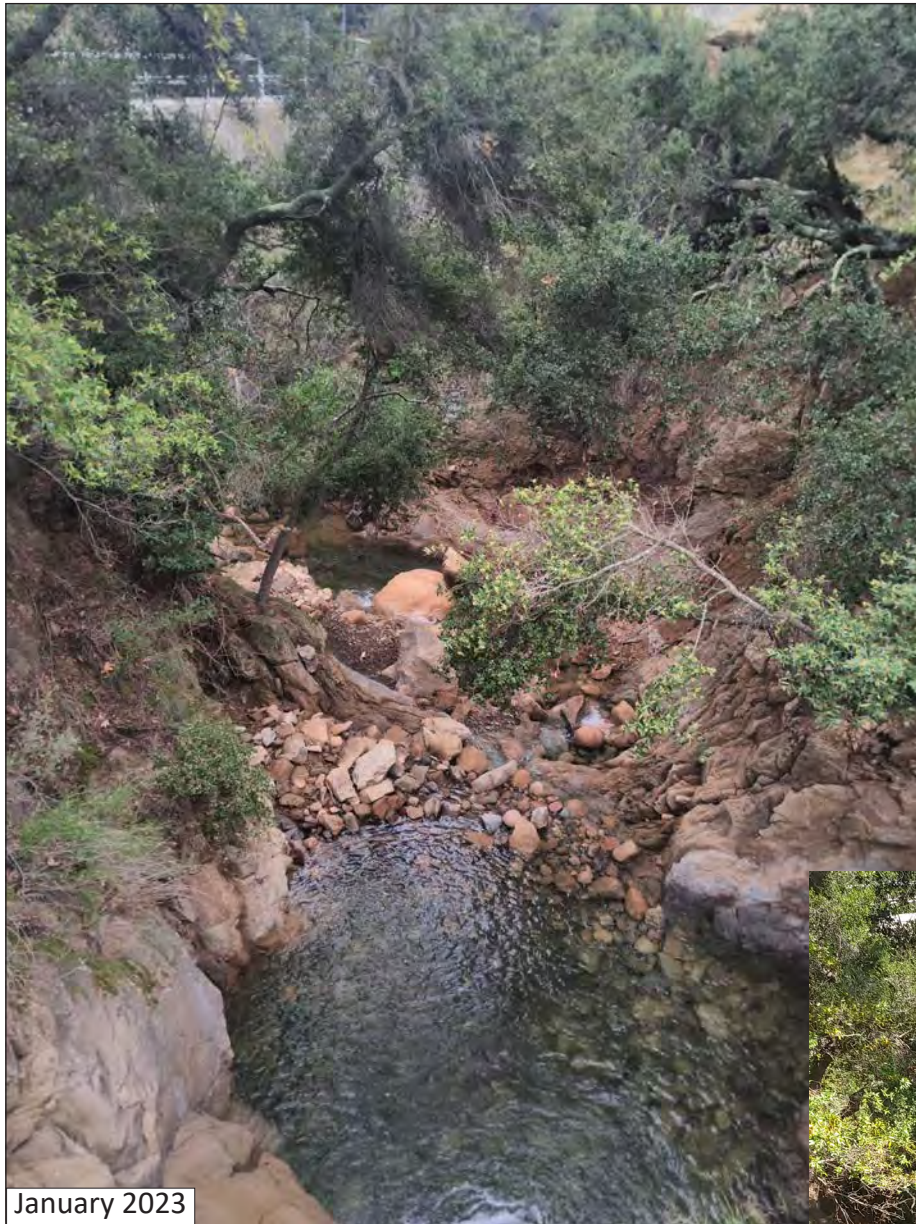
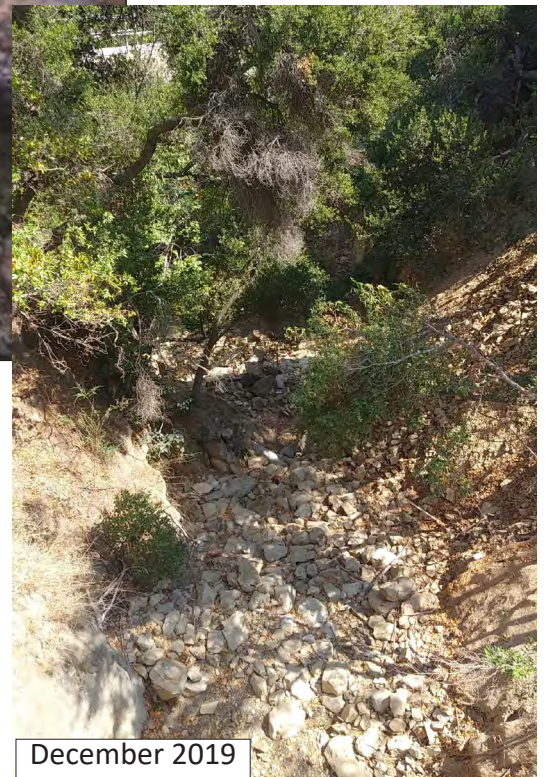
Photograph 2a-b. Creek Sites 2 and 3 Mission Creek pool and riffle habitat below bridge.

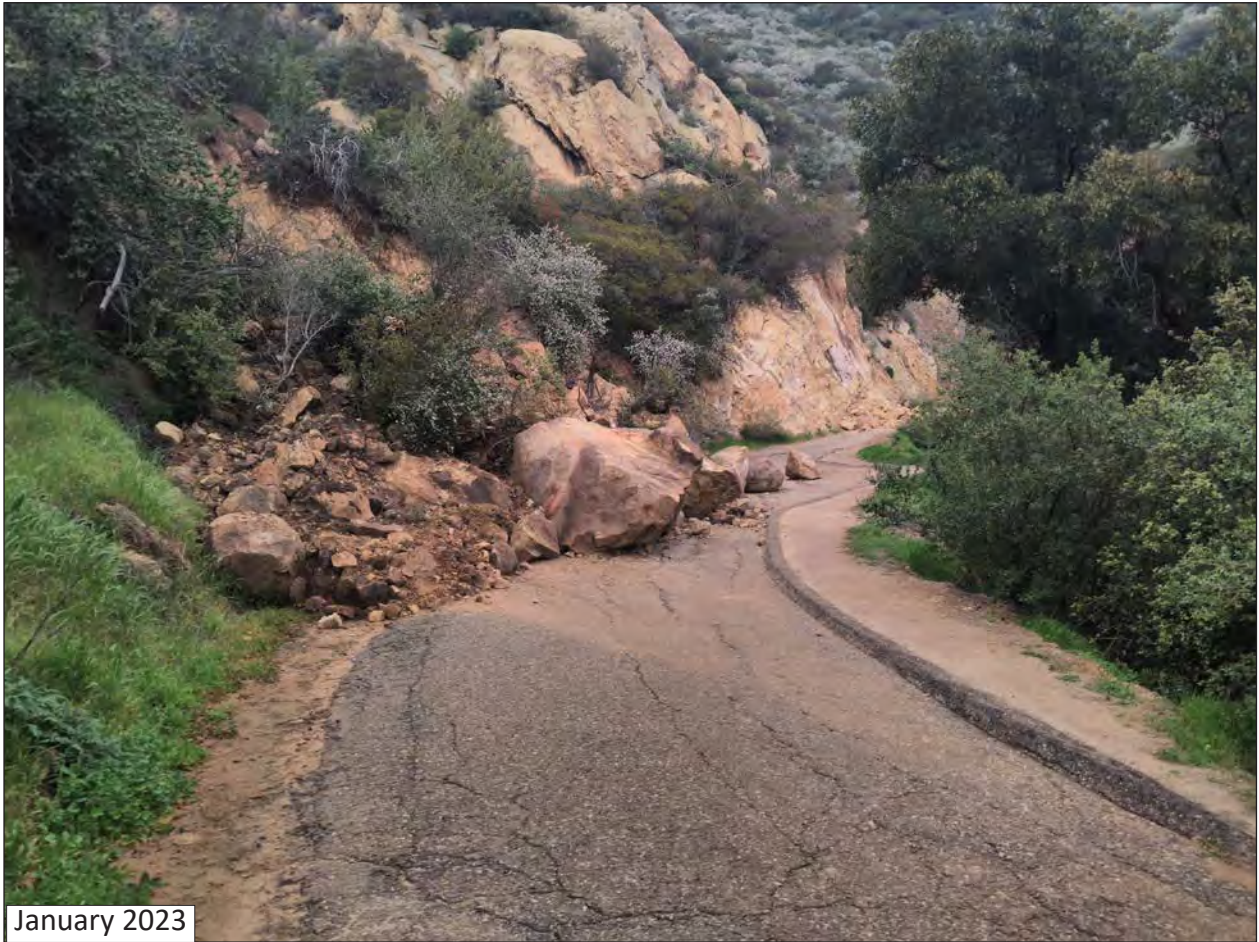
Photograph 3. Spyglass Ridge Road Area 1 with slope failure, looking north.

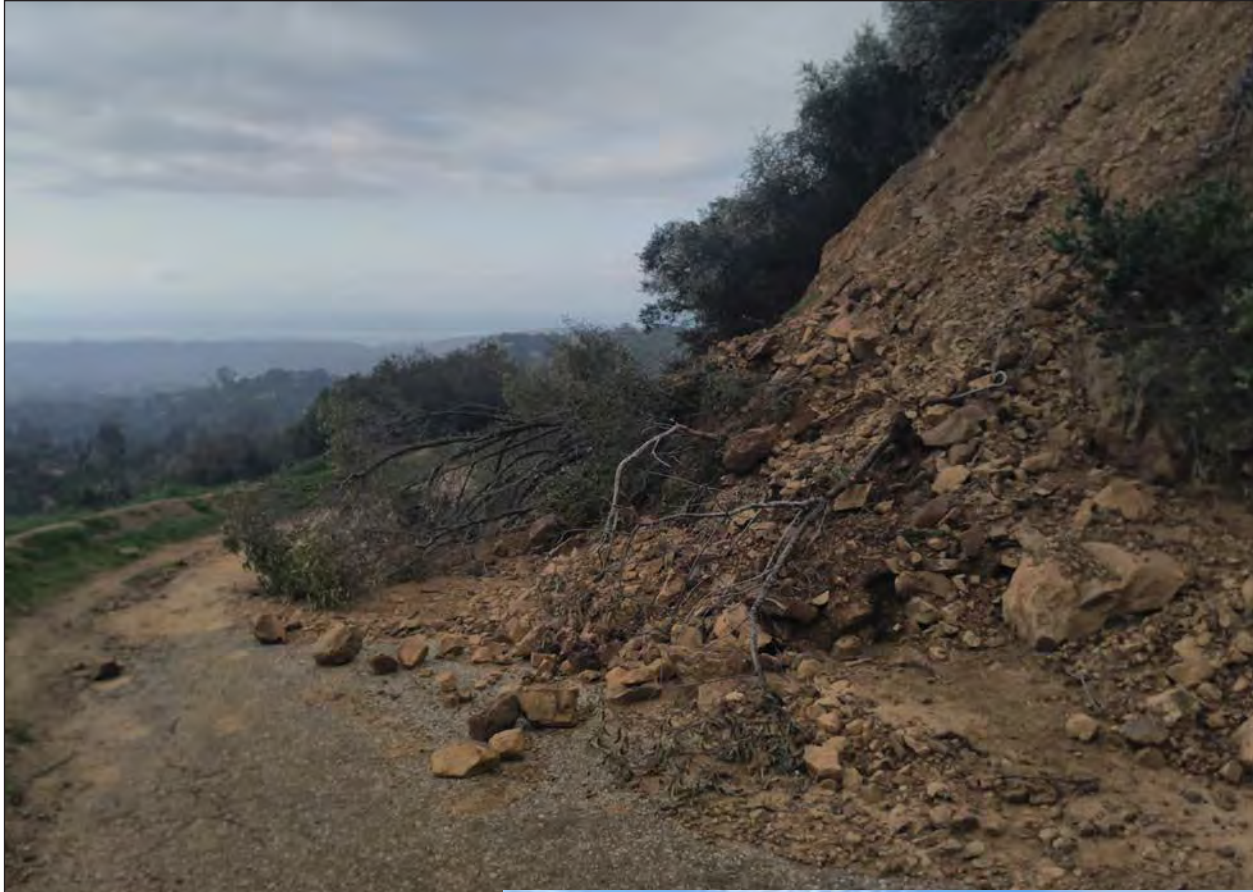
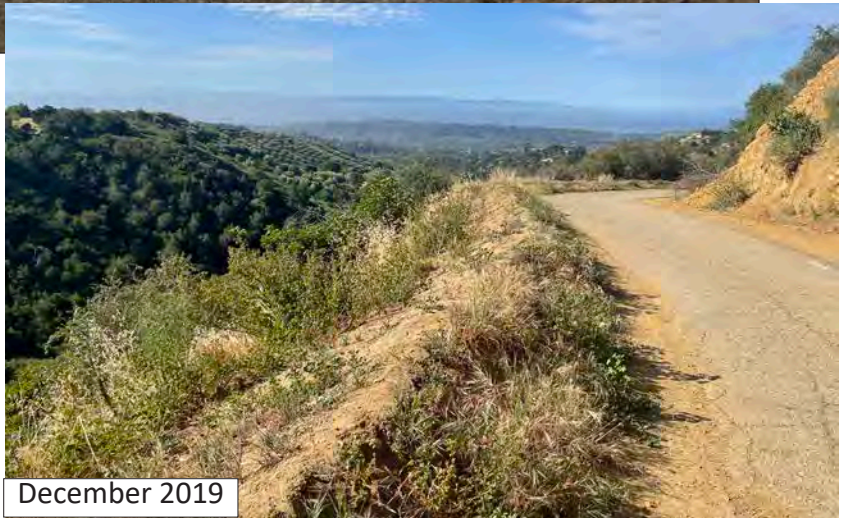
Photograph 4a-b. Spyglass Ridge Road Area 1 slope failure, looking south.

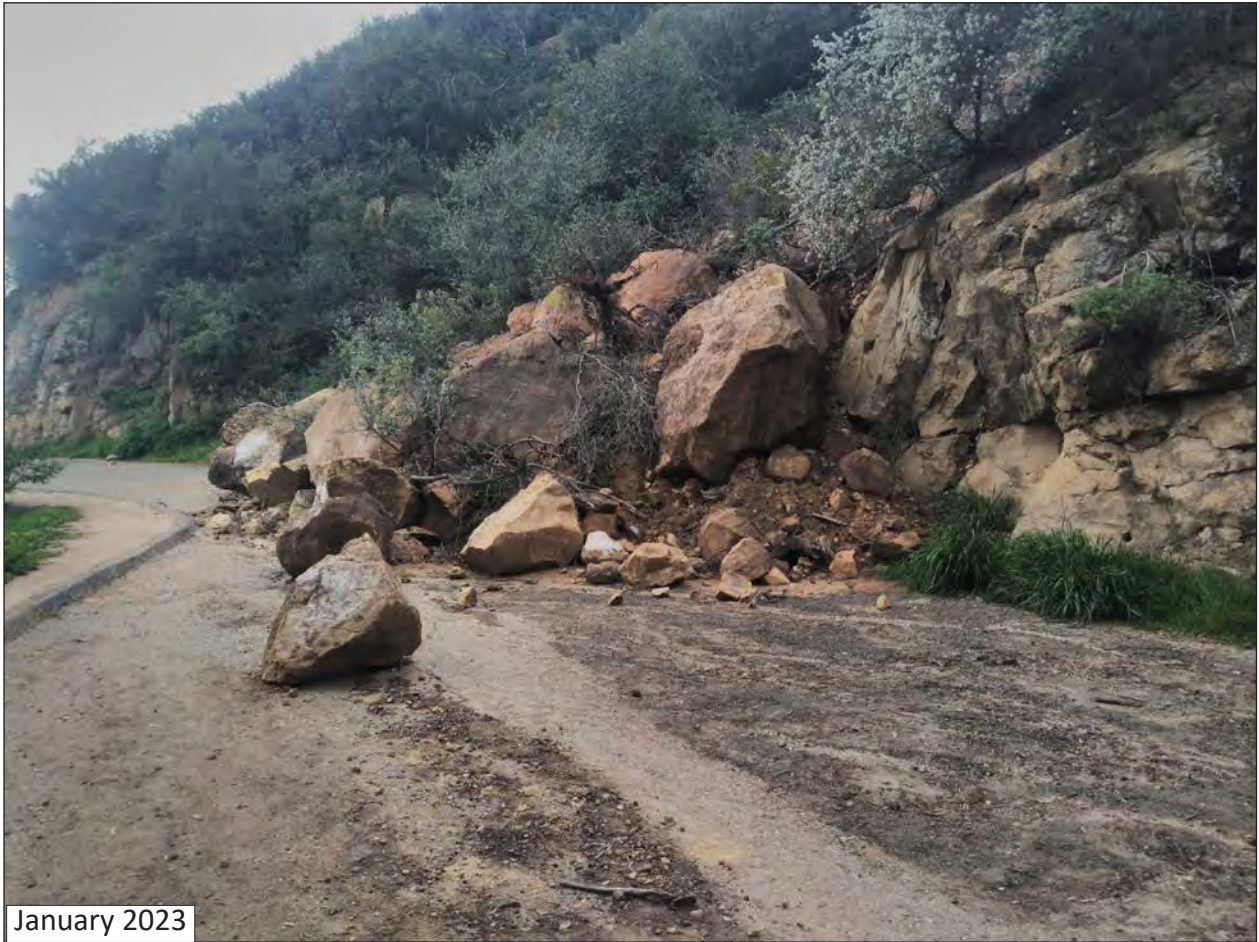
Photograph 5. Spyglass Ridge Road Area 2 with slope failure, looking south.
