Mission Canyon Stream Restoration Project

Jenny McGee
Restoration Project Manager
Southern California Edison

June 6, 2023

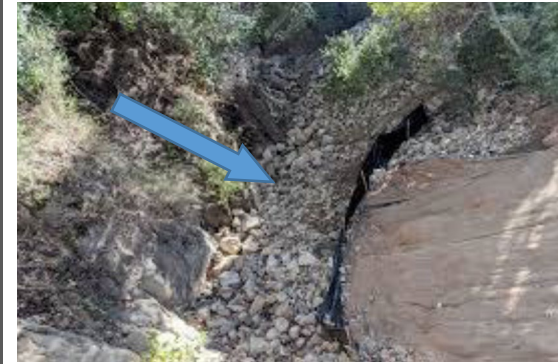
Soil and rock was discharged directly into Mission Creek

- In December 2019, Southern California Edison (SCE) performed road grading and vegetation management
- Rock/ spoils were discharged onto slopes supporting native habitat and into Mission Creek
- This caused impacts to:
 - native vegetation communities,
 - sensitive plant populations,
 - native trees,
 - sensitive wildlife,
 - streambed, resources, and
 - additional indirect impacts to the Mission Canyon ecosystem.
- *Full restoration of this habitat to conditions existing prior to the December 2019 work, including habitat features within the stream, is a primary goal of the Stream Restoration Project.*

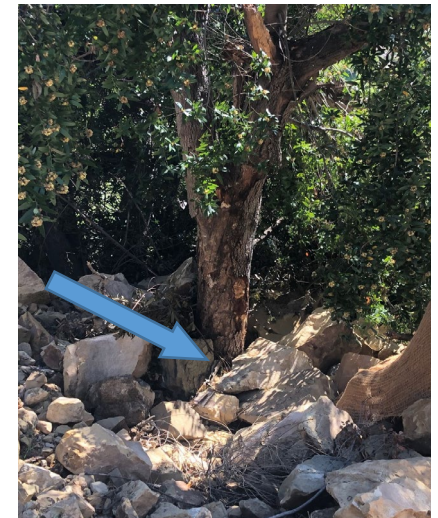
Boulders and rocks deposited against native trees

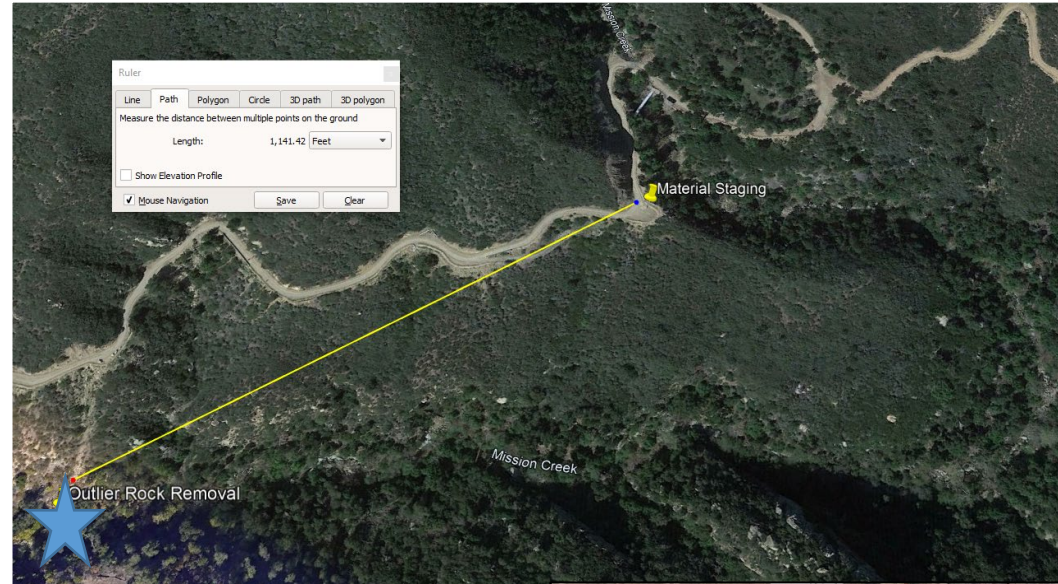
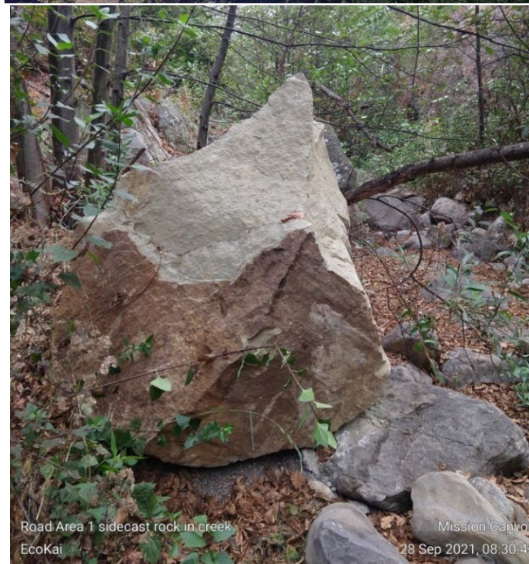
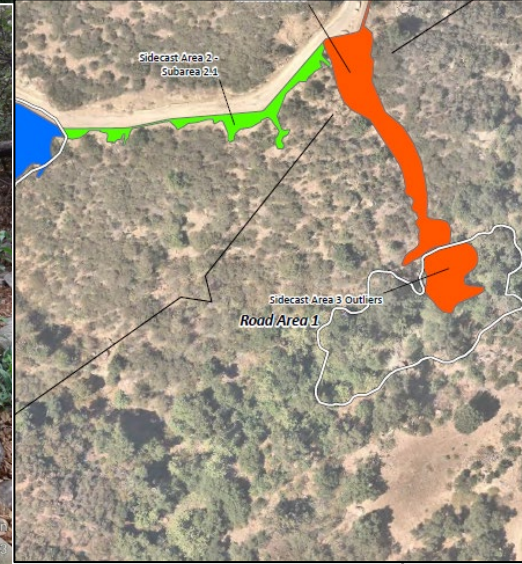
- Large boulders and rock 300 feet from roadside
- No foot or road access
- Use light duty SCE helicopter
- Rock will be manually broken or drilled and injected with an expansive rock breaking agent
- Rock will be loaded by hand crews and staged to minimize flight time
- Helicopter will hover approx. 100-150 above ground
- Flight Duration approx. 3 days
- Will require special training, sterile flight path, safety and fire prevention measures in place

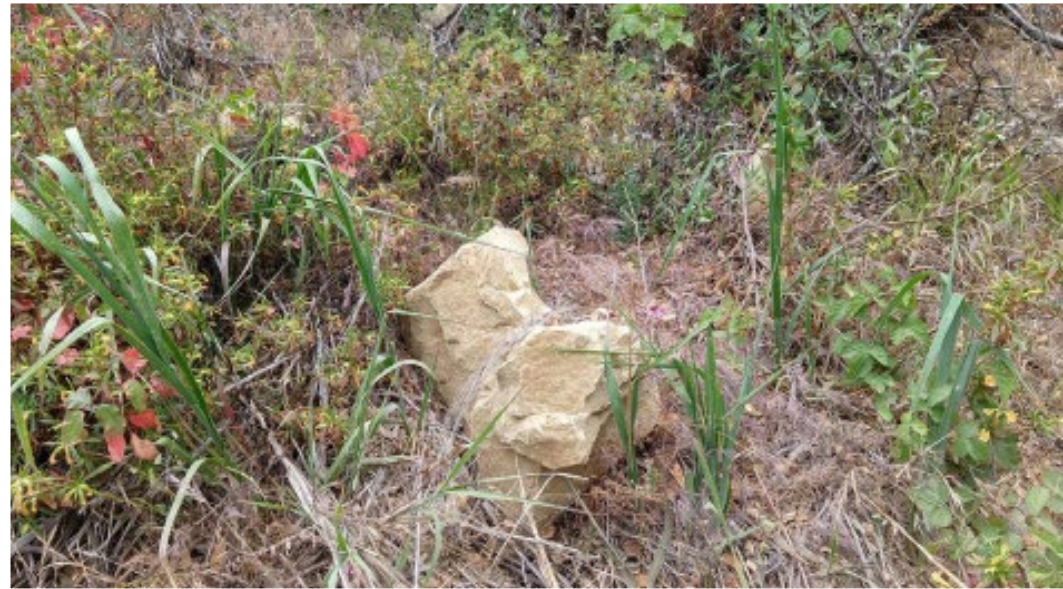
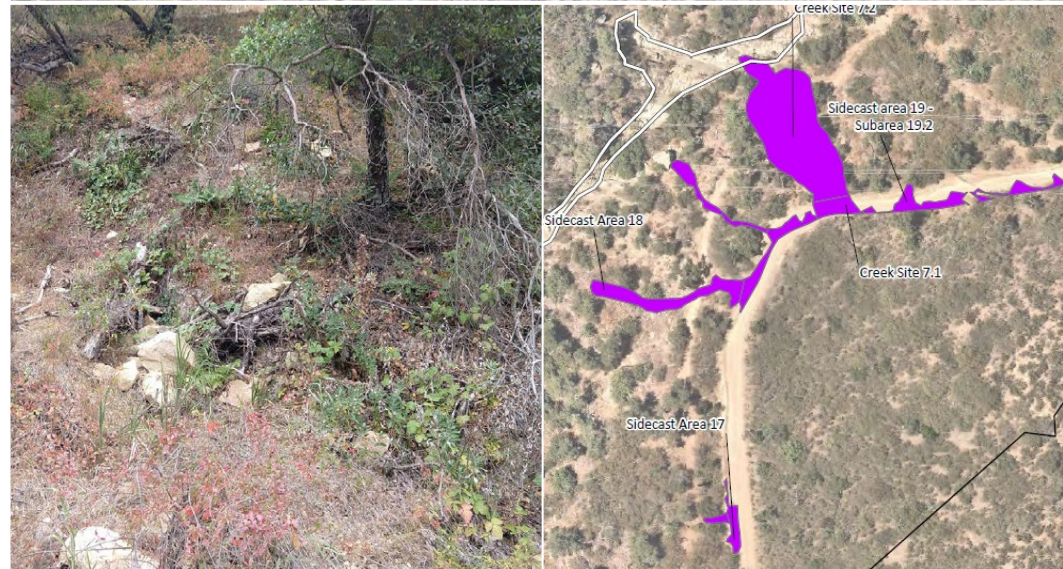
- Consist of scattered rocks intermixed with existing vegetation
- Areas only accessible by foot
- Technicians using fall protection to manually remove rocks and transfer up slope by hand
- Large rocks will be broken; smaller fragments may be placed in packs
- Material will be collected in the road, and transported to designated storage area for haul off

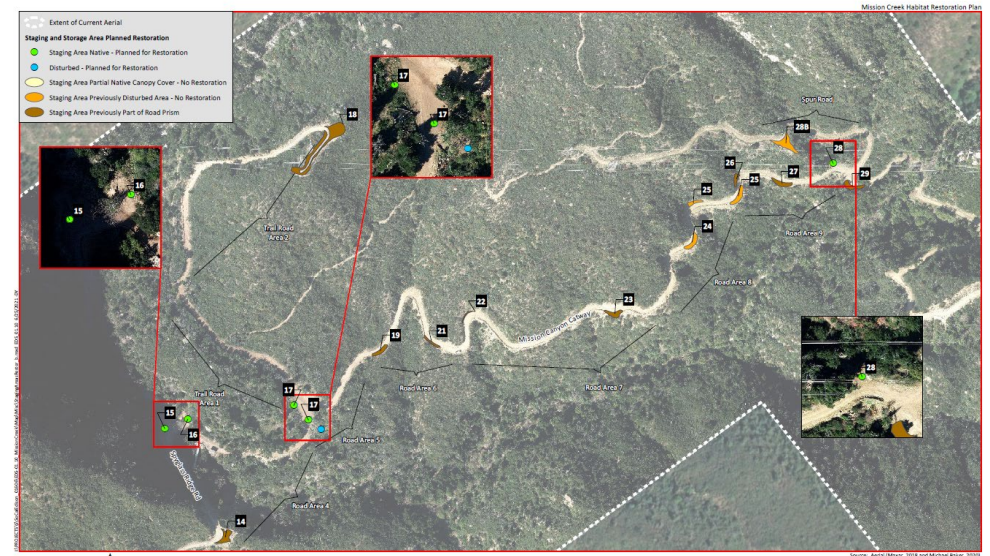
Staging and Storage Areas Planned for Restoration
Figure B

Select staging areas and one additional location previously disturbed (non-SCE related) will be restored to native habitats following Project construction.
