Attachment A

Photographs of Mission Creek
Sidecast Areas

Access Road Maintenance
Project- Tunnel Trail Area,
1/29/2020 and 1/31/2020

Sidecast Material – Volume Estimate,
Mission Creek Access Road,
5/7/2020

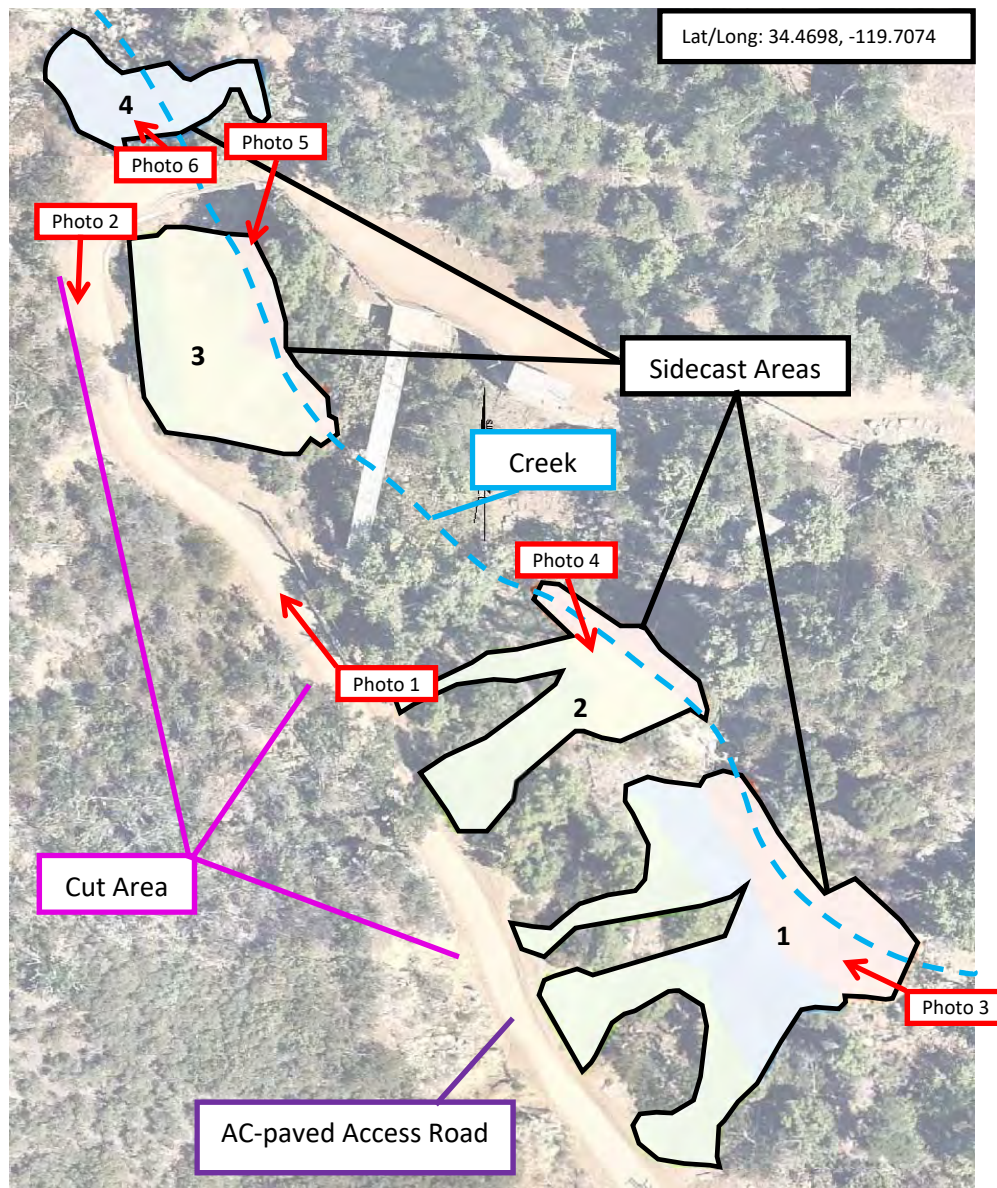
Rock and sediment (sidecast material) from recent roadway grading and maintenance activities were deposited in Mission Creek, which is located in Santa Barbara, California. The material was sidecast from various points along an approximate 400-foot stretch of access road with elevations ranging from 20 to 50 feet above Mission Creek. The estimated volumes of sidecast material were calculated using post-construction Light Detection and Ranging (LiDAR) and survey data that was collected on January 14 and 15, 2020. **This document provides planning-level estimates of the sidecast material volumes and should not be used as the basis for design. All calculations are subject to revision.**

Figure 1: Site overview map showing access road, cut area, sidecast areas, creek, and photo locations.

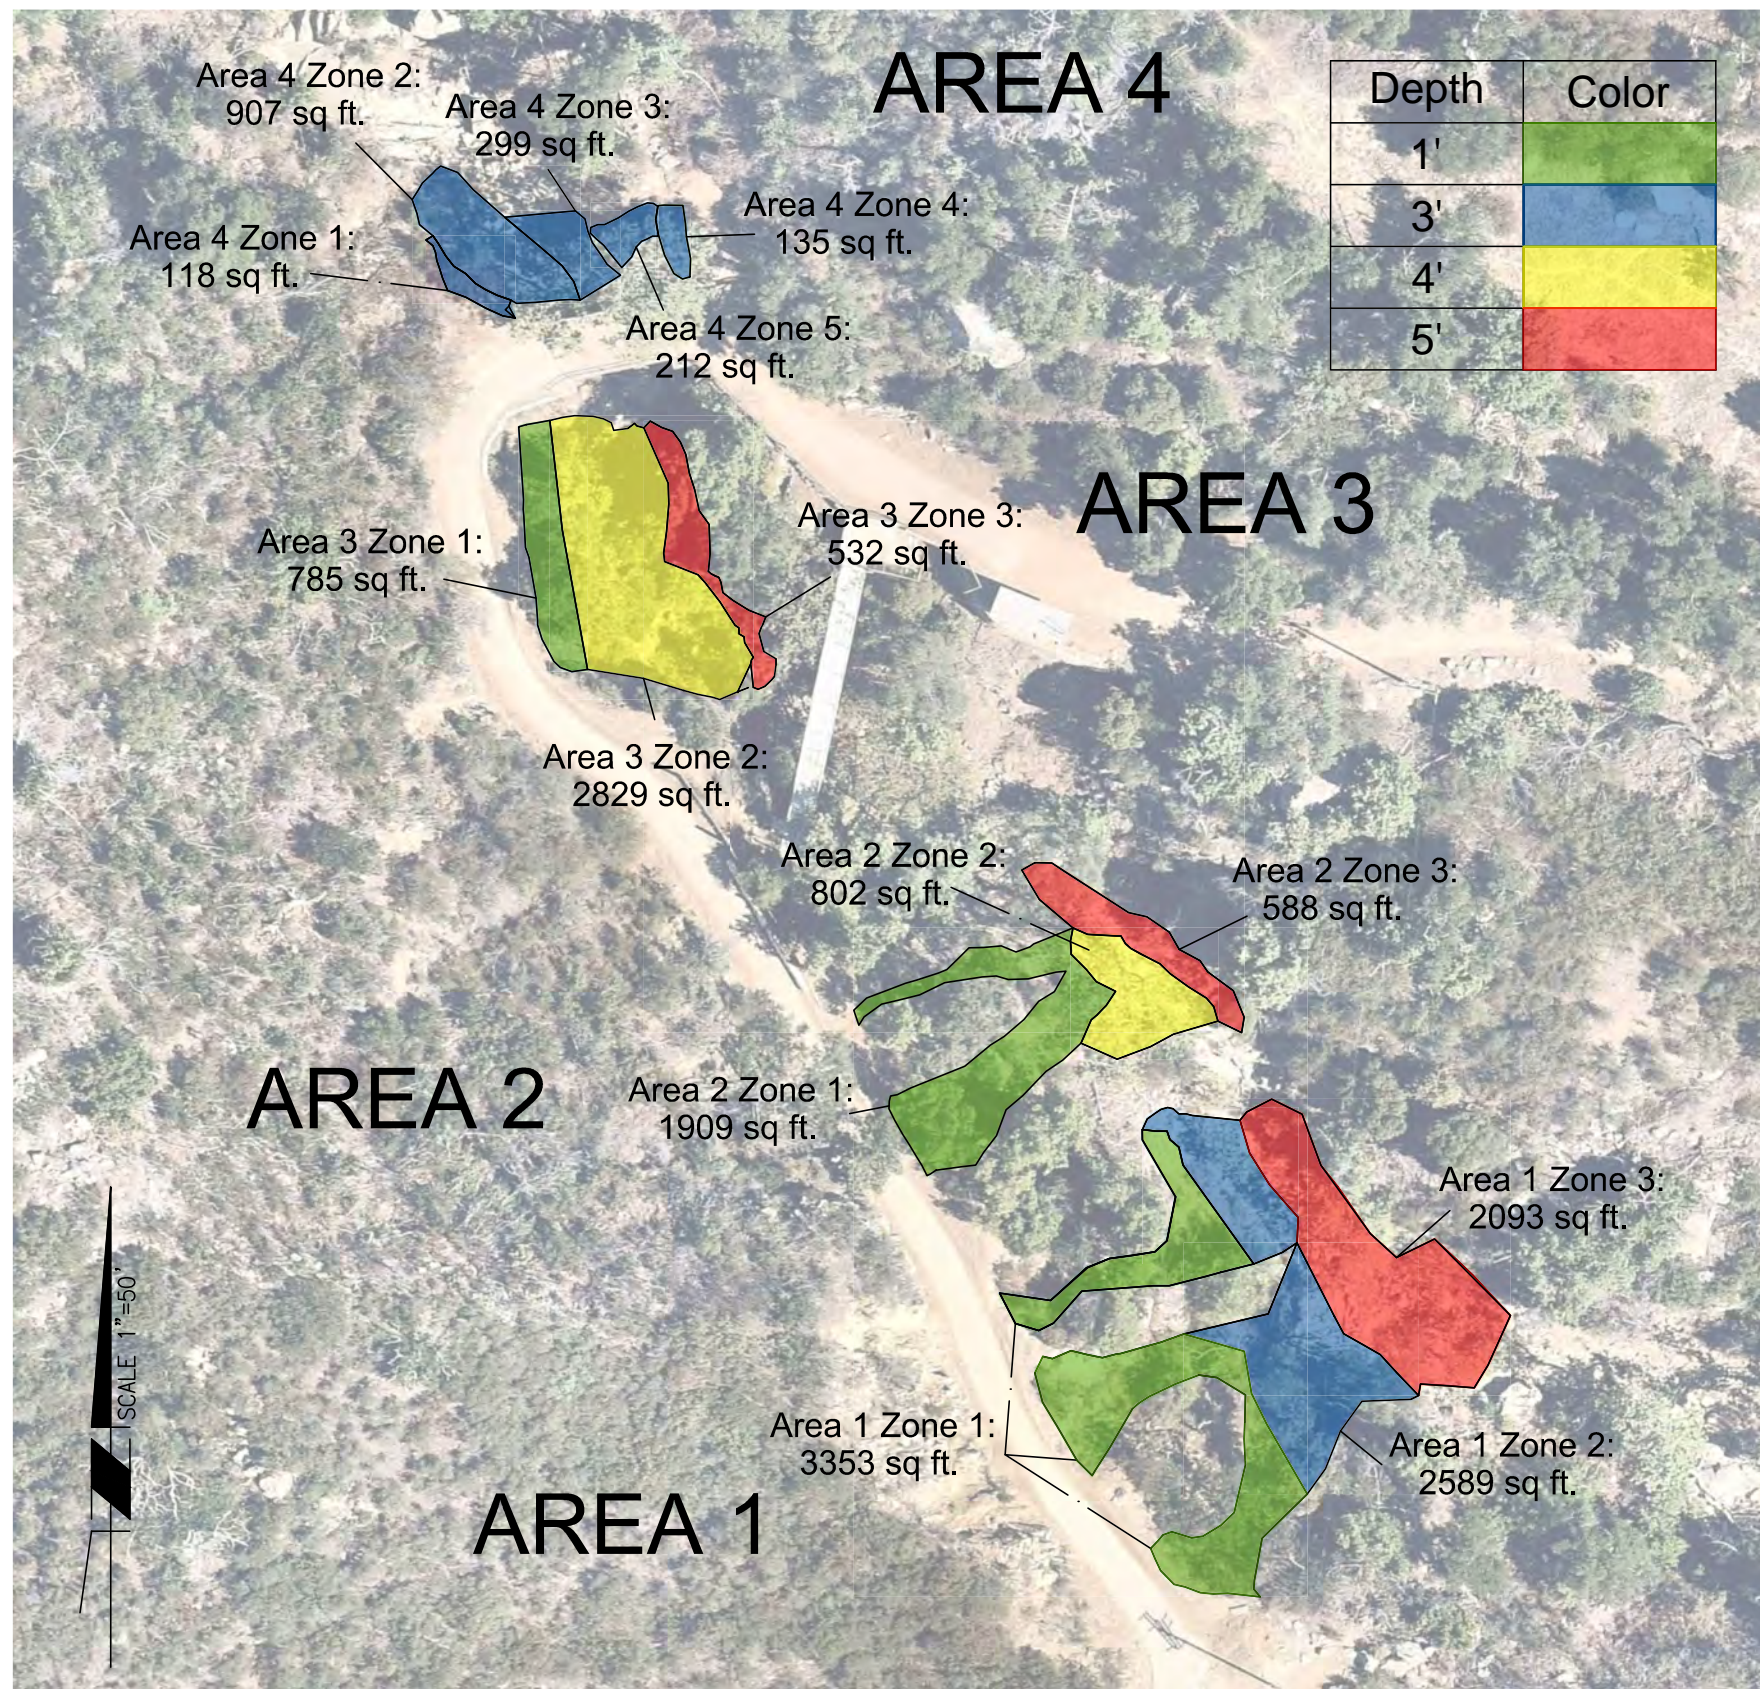
Area 1			
Zone	3D Surface Area	Estimated Depth	Volume
1	3353 SQFT	1'	124 yd ³
2	2589 SQFT	3'	288 yd ³
3	2093 SQFT	5'	388 yd ³
	8035 SQFT	Total	800 yd³

Area 2			
Zone	3D Surface Area	Estimated Depth	Volume
1	1909 SQFT	1'	71 yd ³
2	802 SQFT	4'	119 yd ³
3	588 SQFT	5'	109 yd ³
	3299 SQFT	Total	299 yd³

Area 3			
Zone	3D Surface Area	Estimated Depth	Volume
1	785 SQFT	1'	29 yd ³
2	2829 SQFT	4'	419 yd ³
3	532 SQFT	5'	99 yd ³
	4146 SQFT	Total	547 yd³

Area 4			
Zone	3D Surface Area	Estimated Depth	Volume
1	118 SQFT	3'	13 yd ³
2	907 SQFT	3'	101 yd ³
3	299 SQFT	3'	33 yd ³
4	135 SQFT	3'	15 yd ³
5	212 SQFT	3'	24 yd ³
	1671 SQFT	Total	186 yd³

A1	800 yd ³
A2	299 yd ³
A3	547 yd ³
A4	186 yd ³
Total	1832 yd³

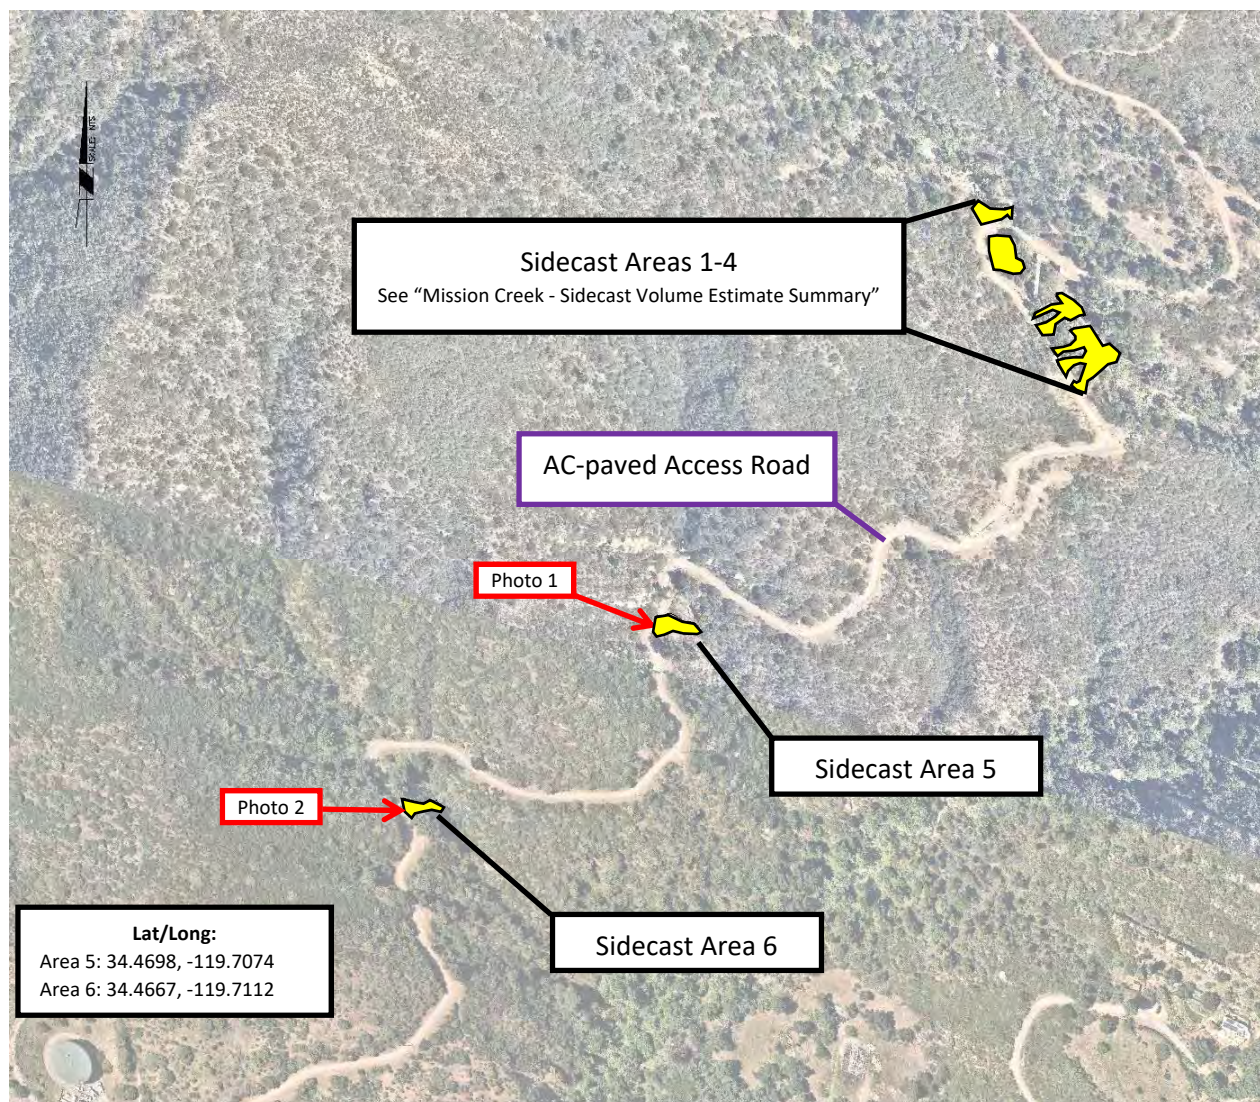
Rock and sediment (sidecast material) from recent roadway grading and maintenance activities were deposited in steep canyons along Spyglass Ridge Road, which is located in Santa Barbara, California. The material was sidecast into steep canyons at two points along the AC-paved access road. The estimated volumes of sidecast material were calculated using post-construction Light Detection and Ranging (LiDAR), survey data, and assumptions of pre-grading average cross sectional geometry in the canyons due to the absence of pre-grading topography. The LiDAR and survey data were collected on January 14 and 15, 2020. **This document provides planning-level estimates of the sidecast material volumes.**

Figure 1: Site overview map showing access road, sidecast areas, and photo locations.

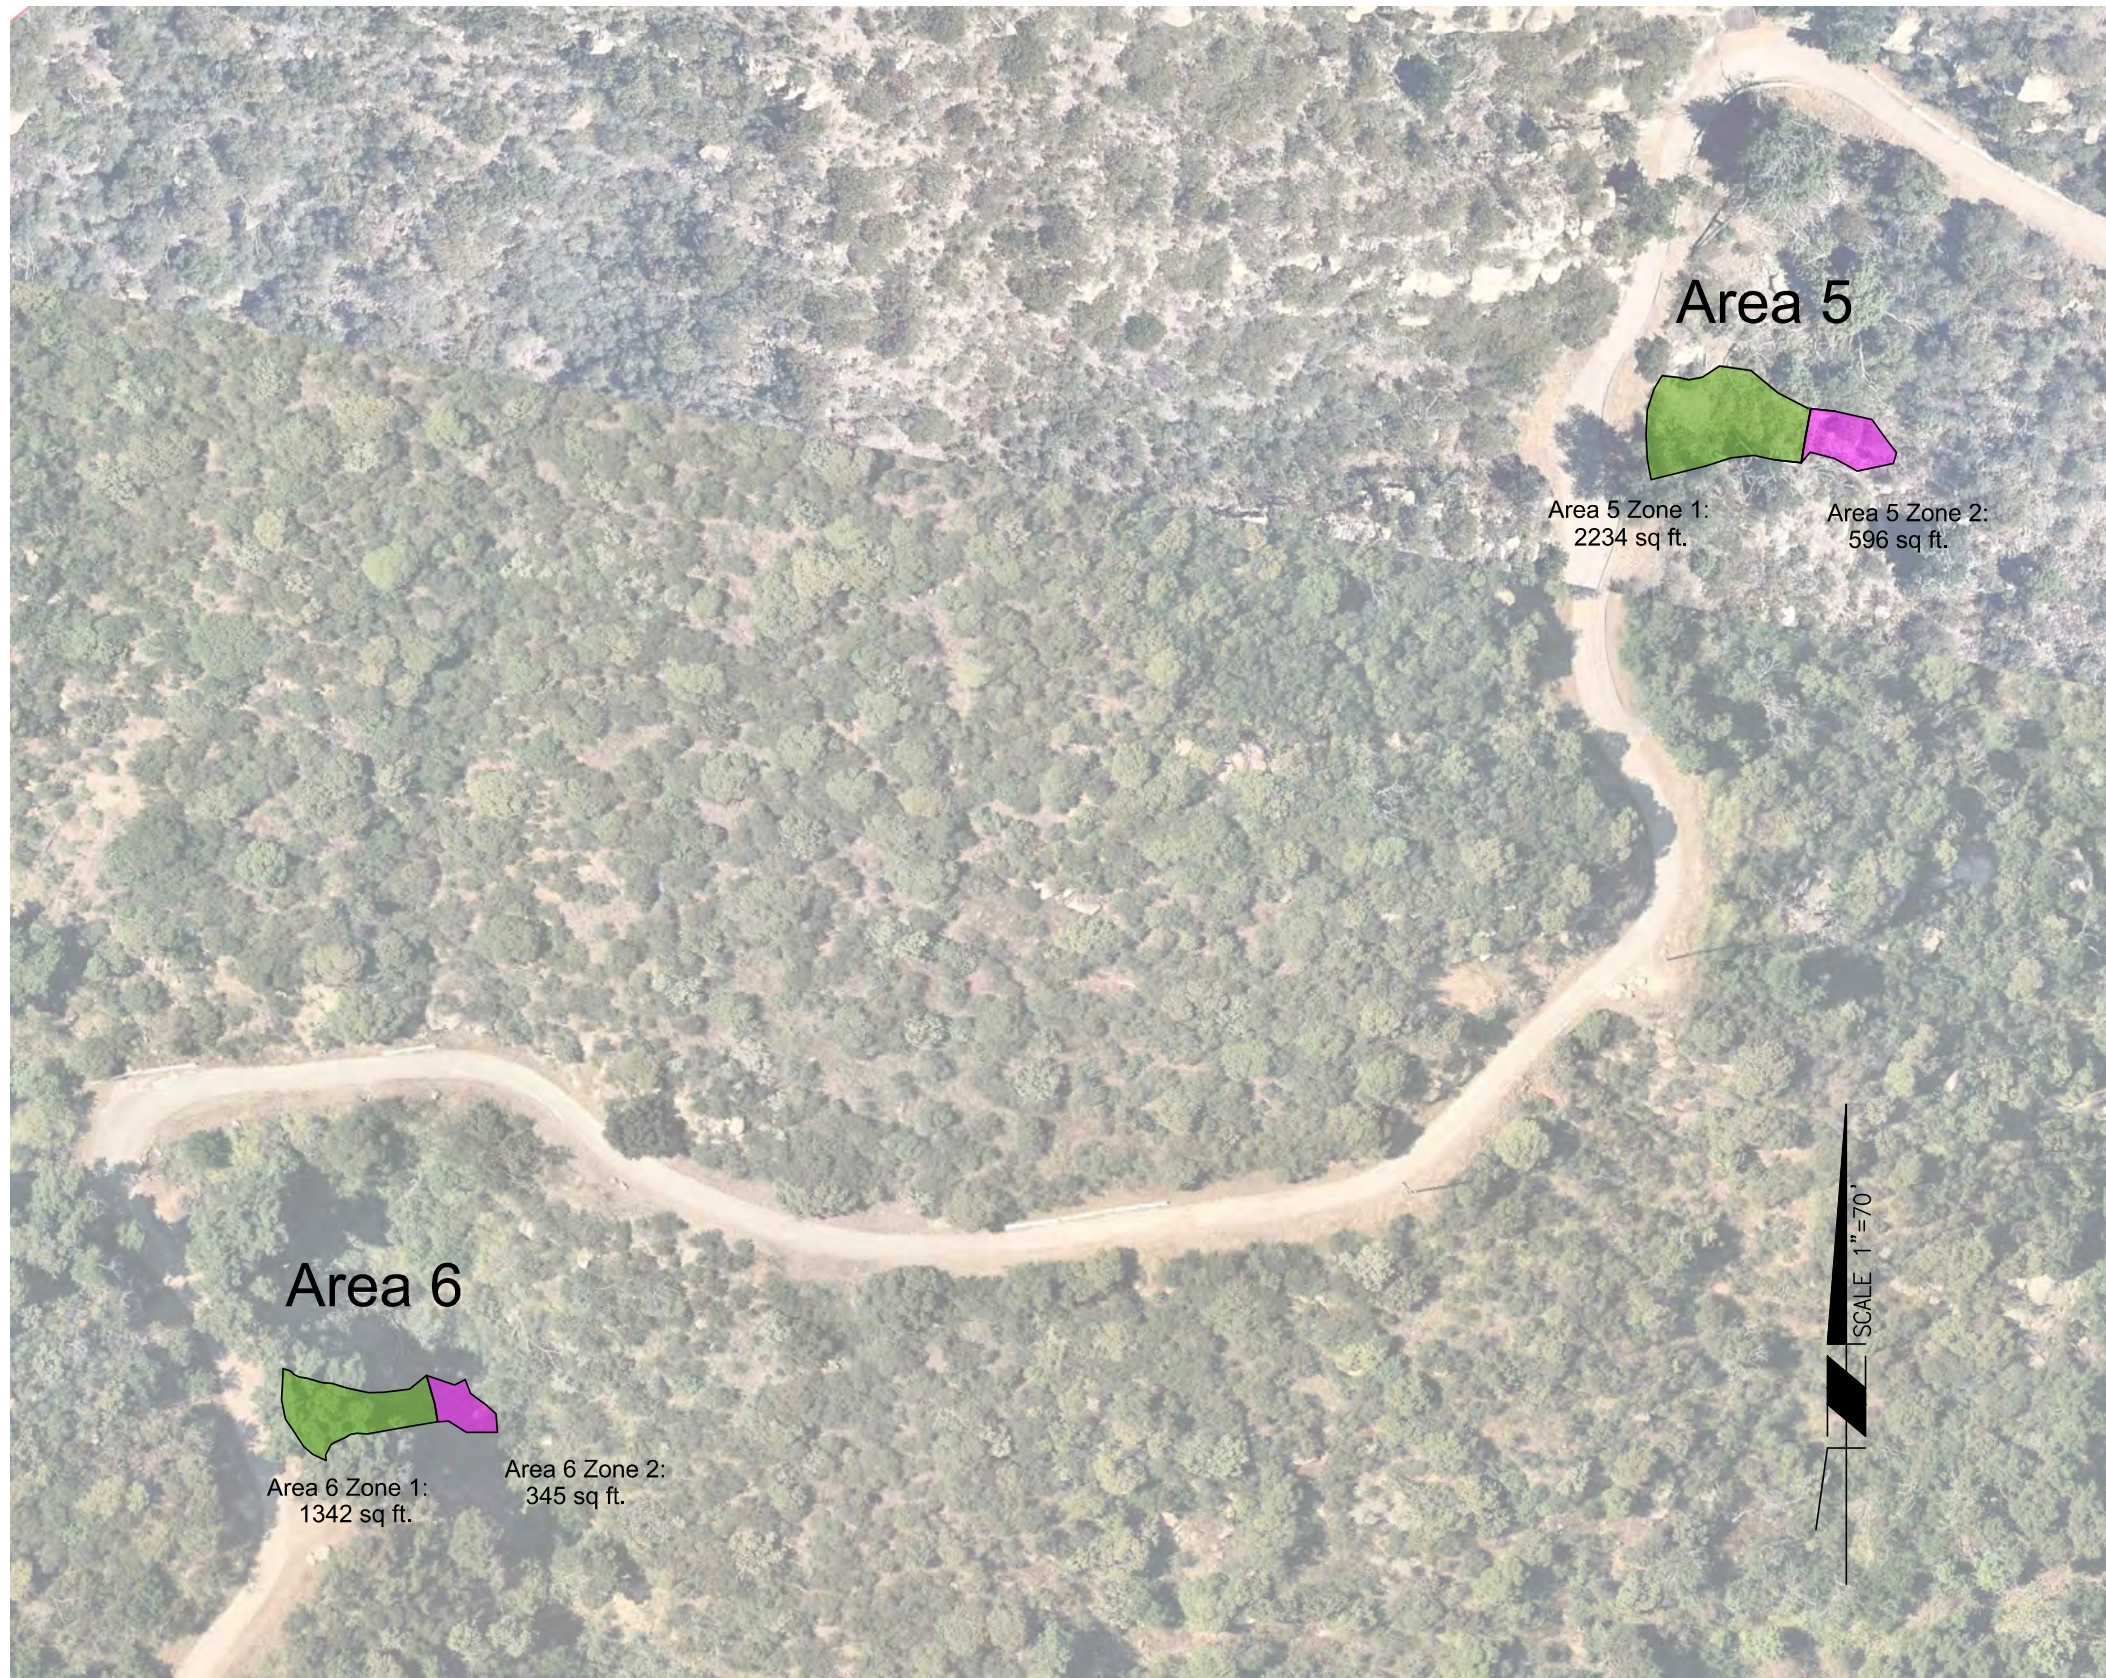
Area 5			
Zone	3D Surface Area	Estimated Depth	Volume
1	2234 SQFT	1'	83 yd ³
2	596 SQFT	2'	44 yd ³
	2830 SQFT	Total	127 yd³
Area 6			
Zone	3D Surface Area	Estimated Depth	Volume
1	1342 SQFT	1'	50 yd ³
2	345 SQFT	2'	26 yd ³
	1687 SQFT	Total	76 yd³

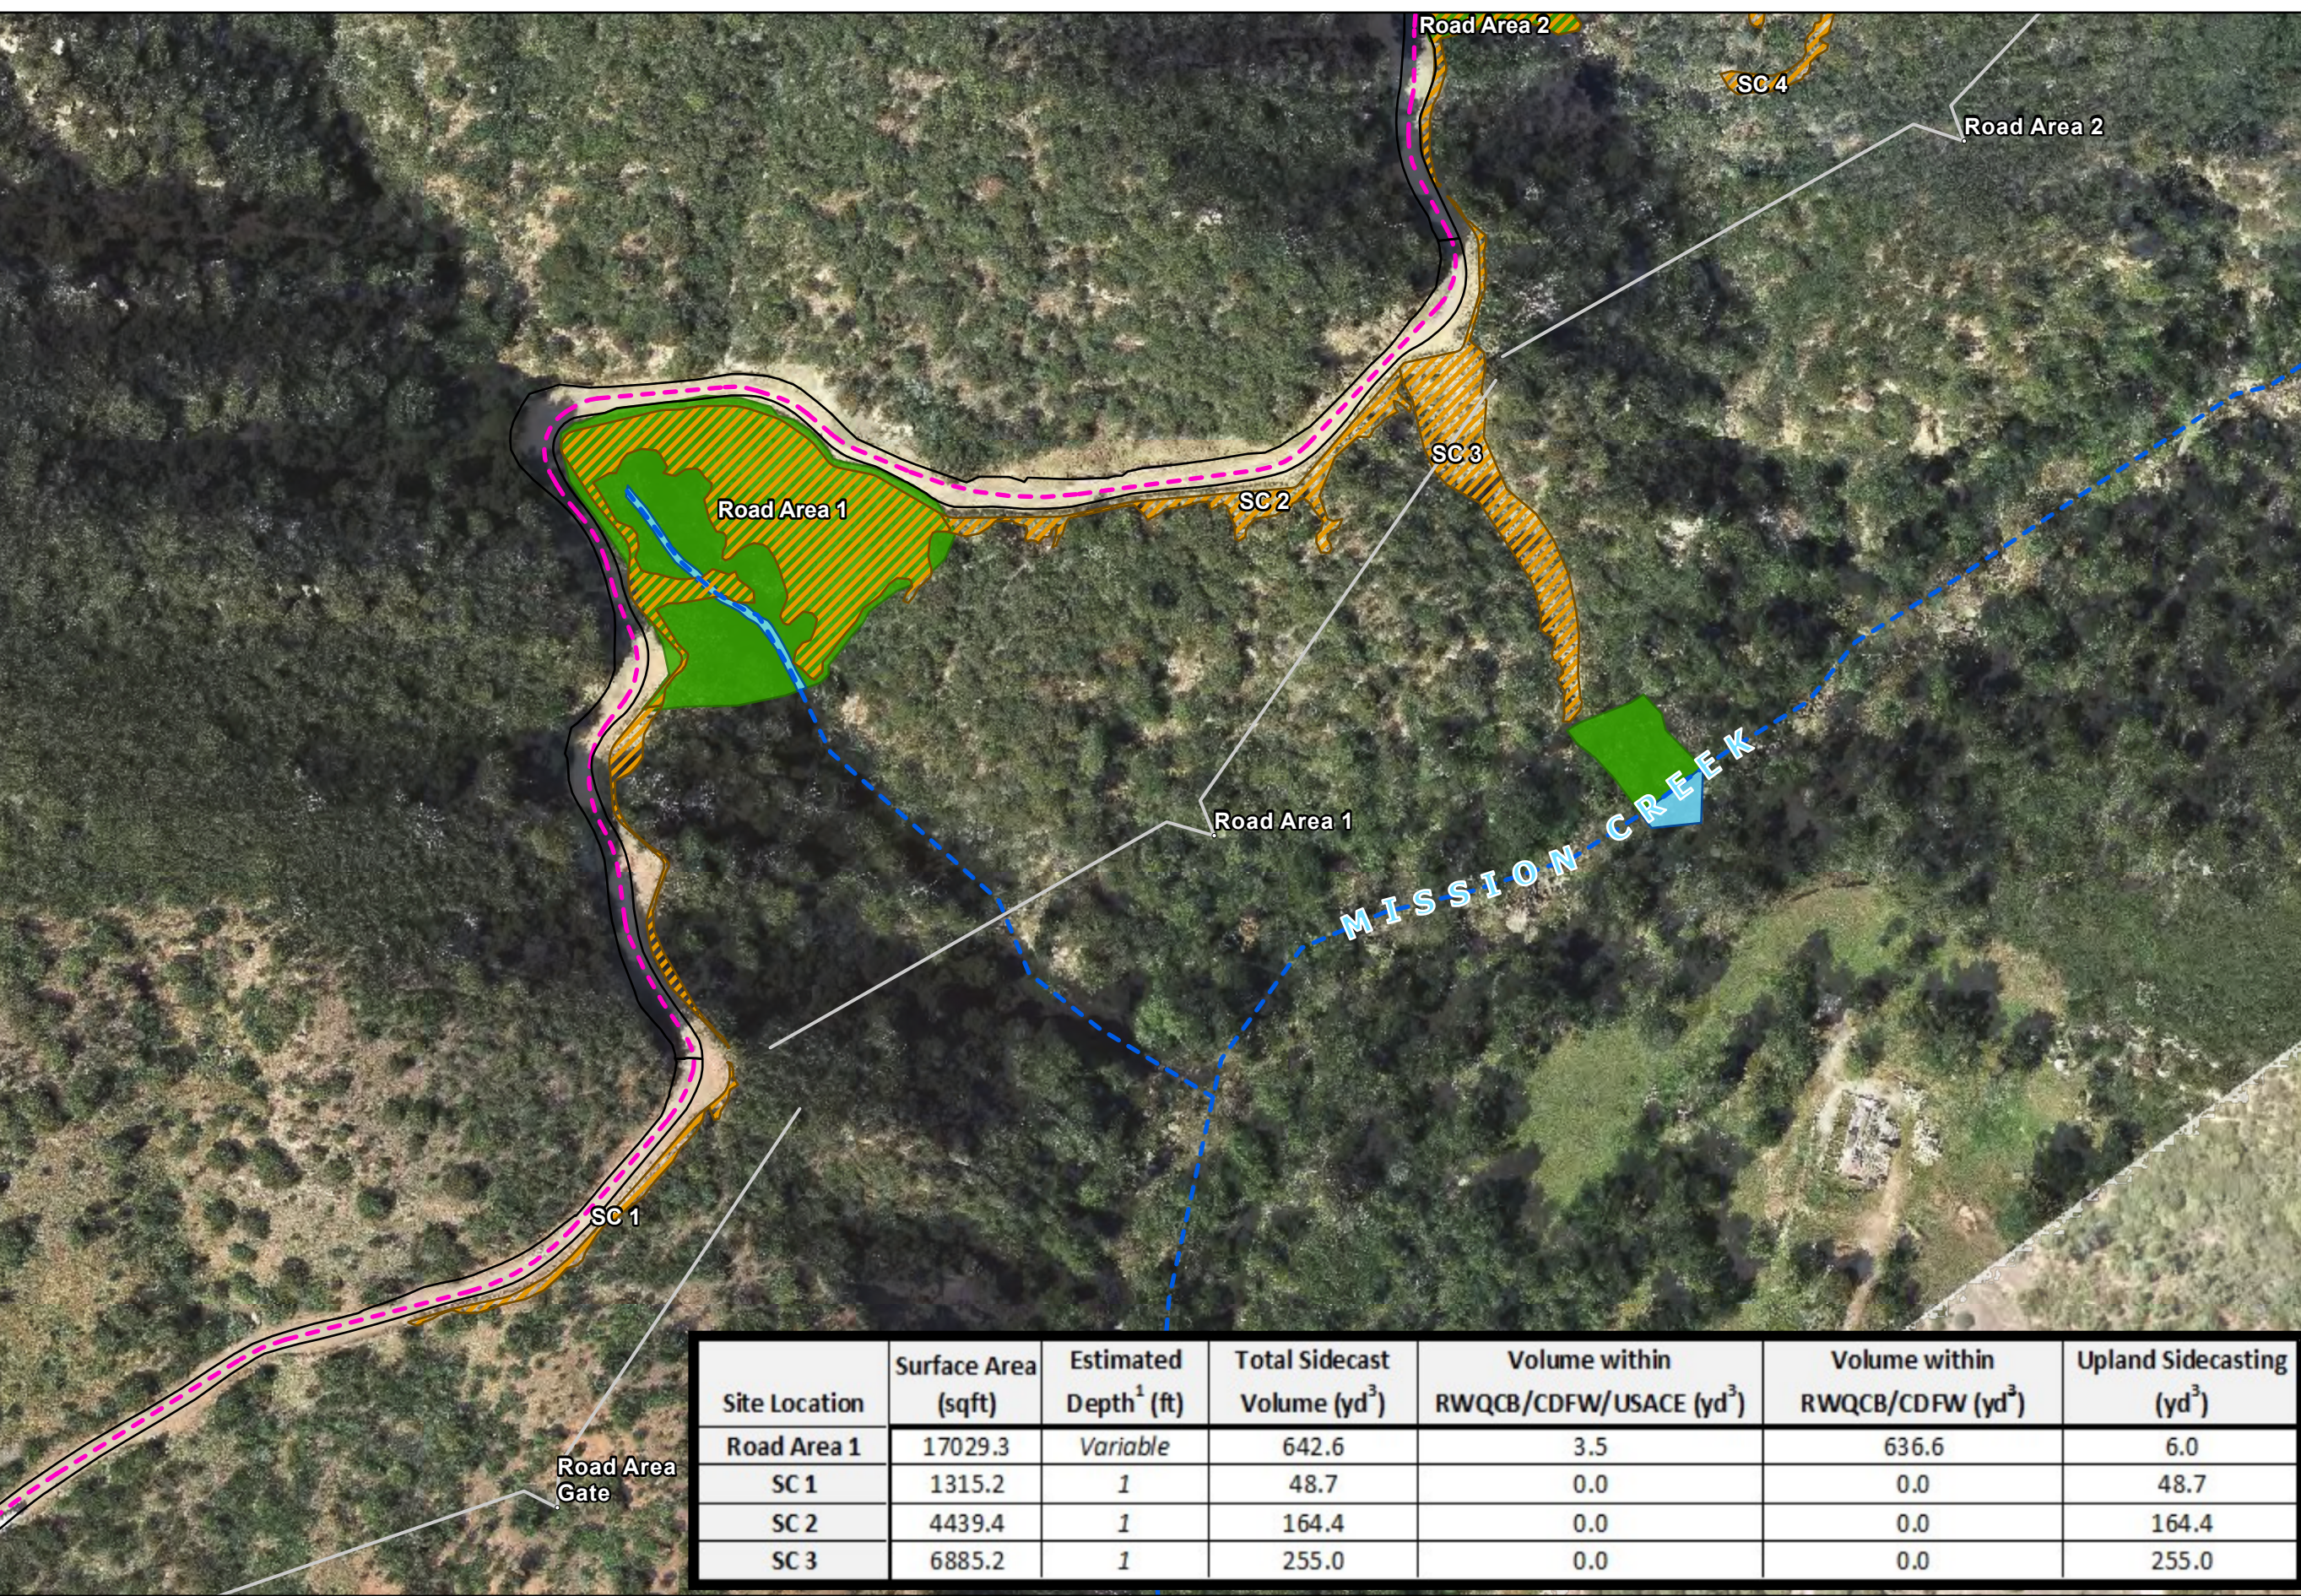
Site Location	Surface Area (sqft)	Estimated Depth ¹ (ft)	Total Sidecast Volume (yd ³)	Volume within RWQCB/CDFW/USACE (yd ³)	Volume within RWQCB/CDFW (yd ³)	Upland Sidecasting (yd ³)
Road Area 1	17029.3	Variable	642.6	3.5	636.6	6.0
SC 1	1315.2	1	48.7	0.0	0.0	48.7
SC 2	4439.4	1	164.4	0.0	0.0	164.4
SC 3	6885.2	1	255.0	0.0	0.0	255.0

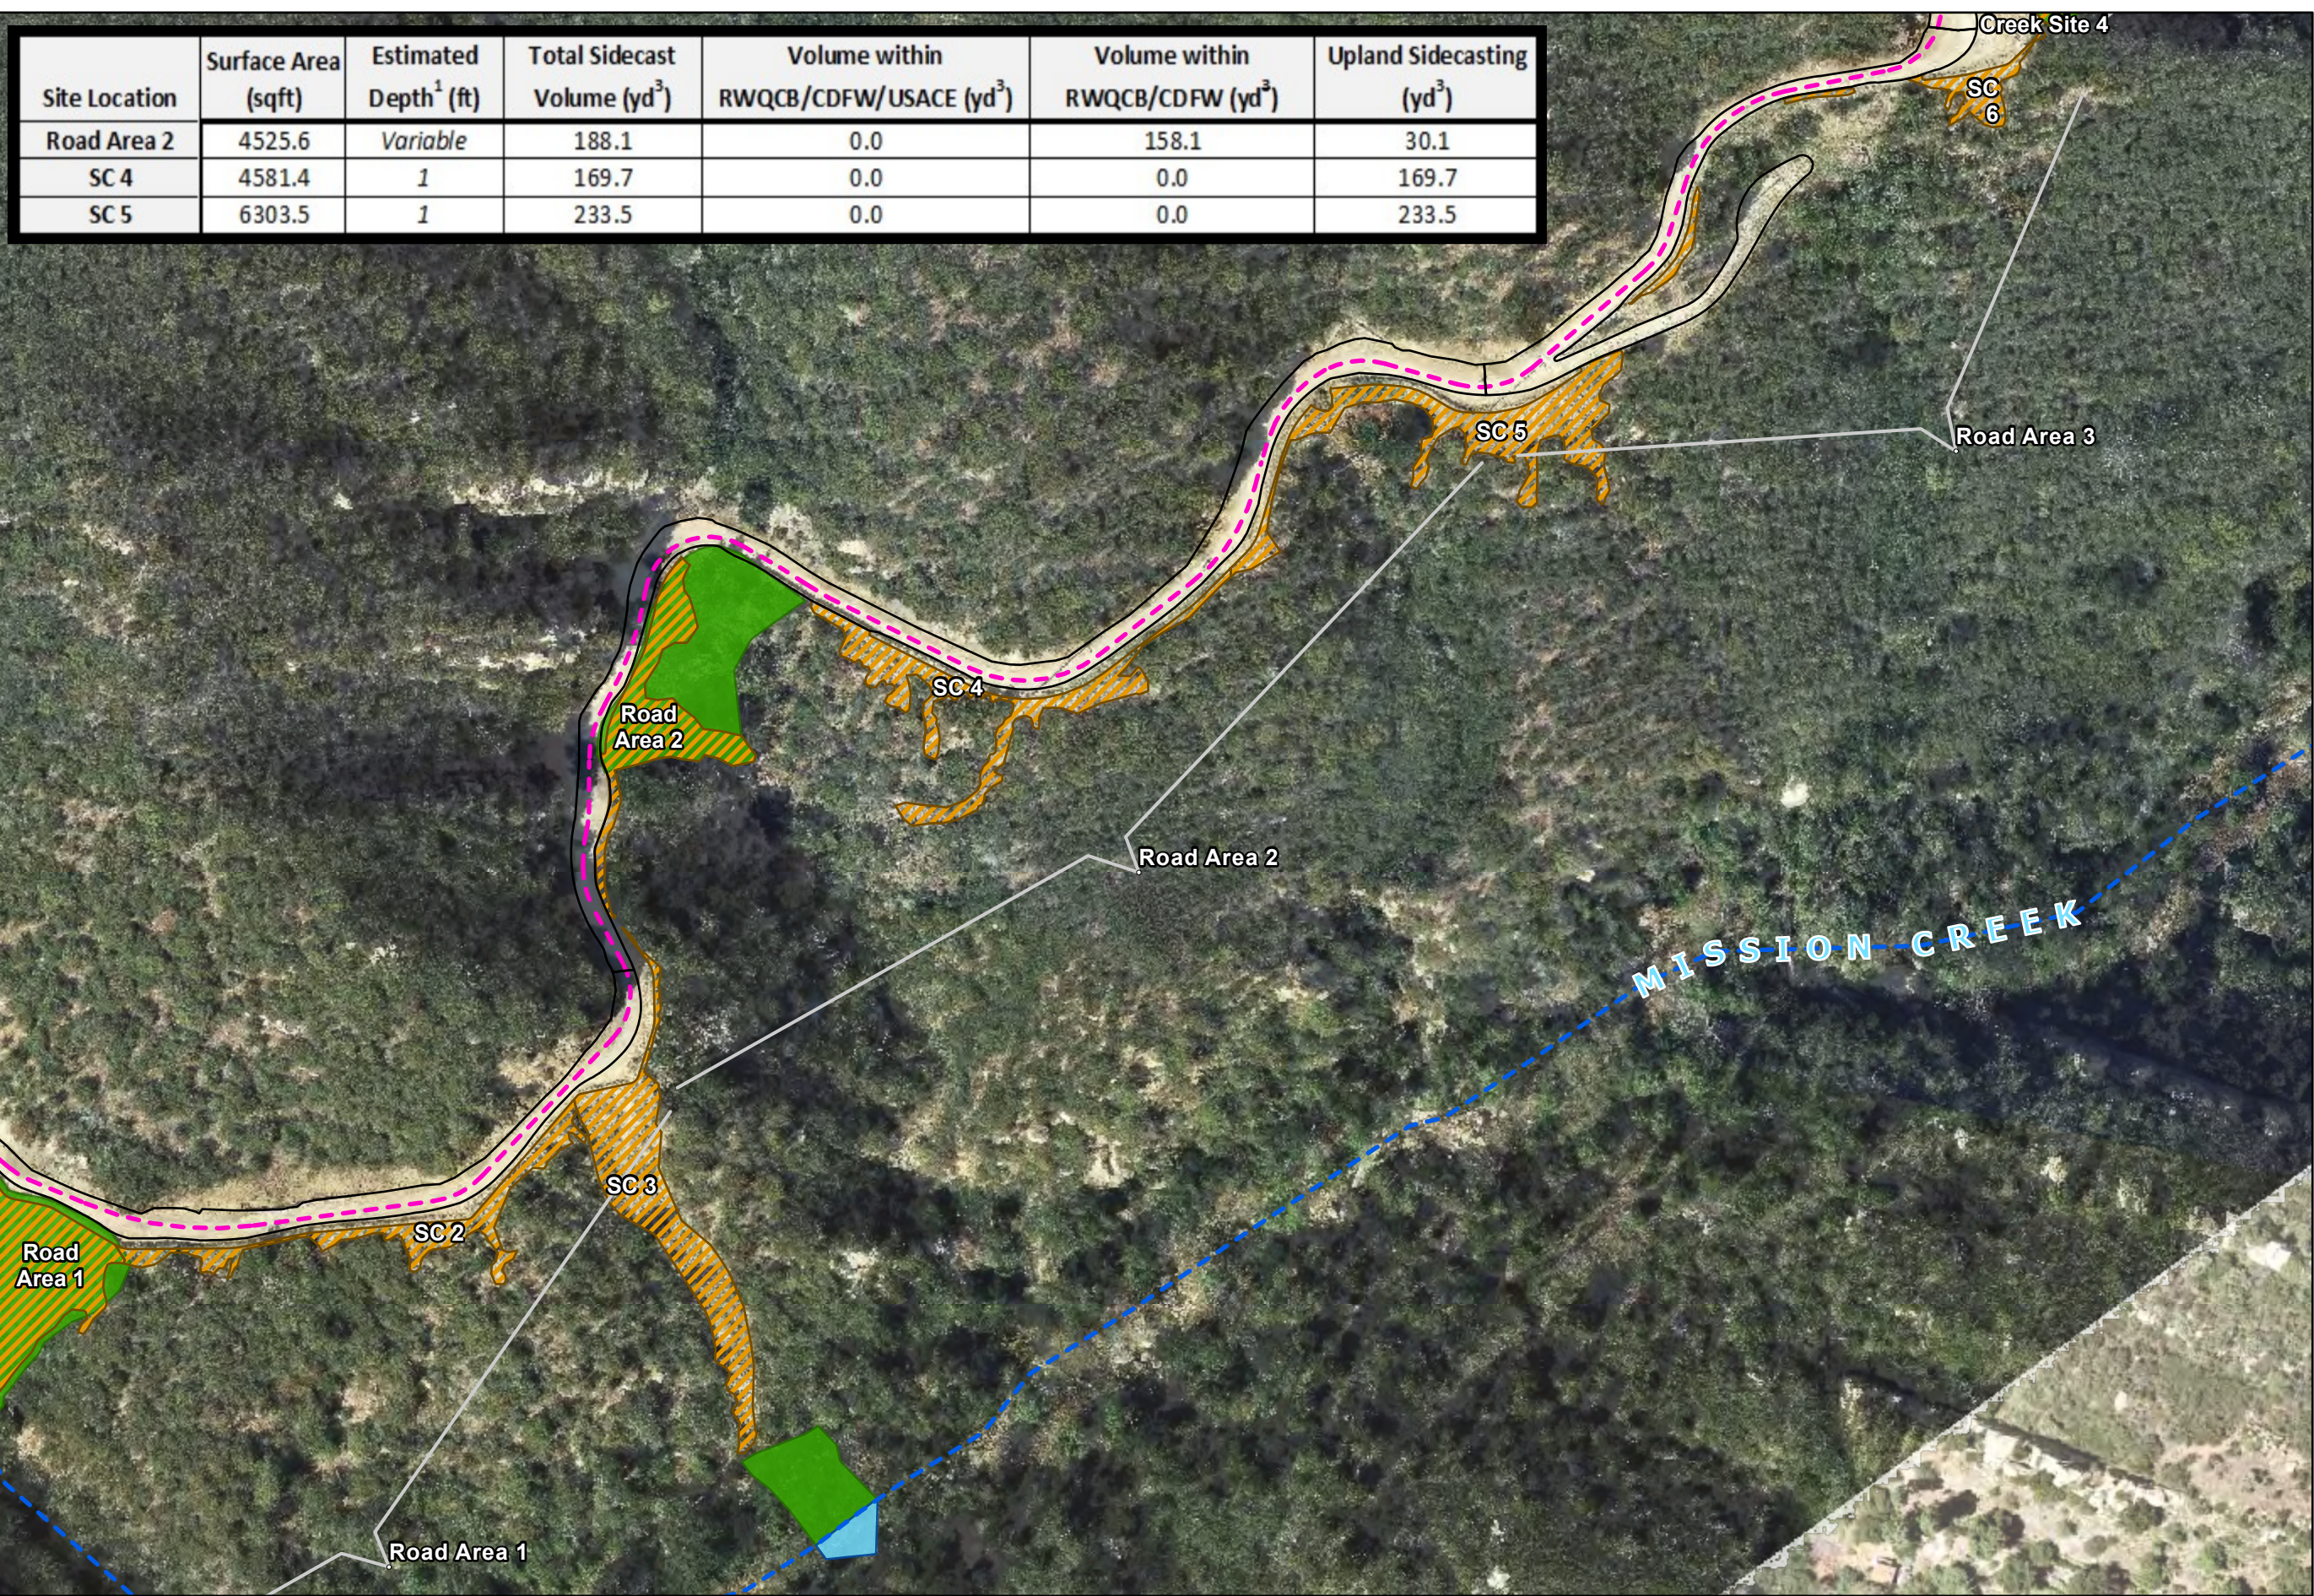
Site Location	Surface Area (sqft)	Estimated Depth ¹ (ft)	Total Sidecast Volume (yd ³)	Volume within RWQCB/CDFW/USACE (yd ³)	Volume within RWQCB/CDFW (yd ³)	Upland Sidecasting (yd ³)
Road Area 2	4525.6	Variable	188.1	0.0	158.1	30.1
SC 4	4581.4	1	169.7	0.0	0.0	169.7
SC 5	6303.5	1	233.5	0.0	0.0	233.5

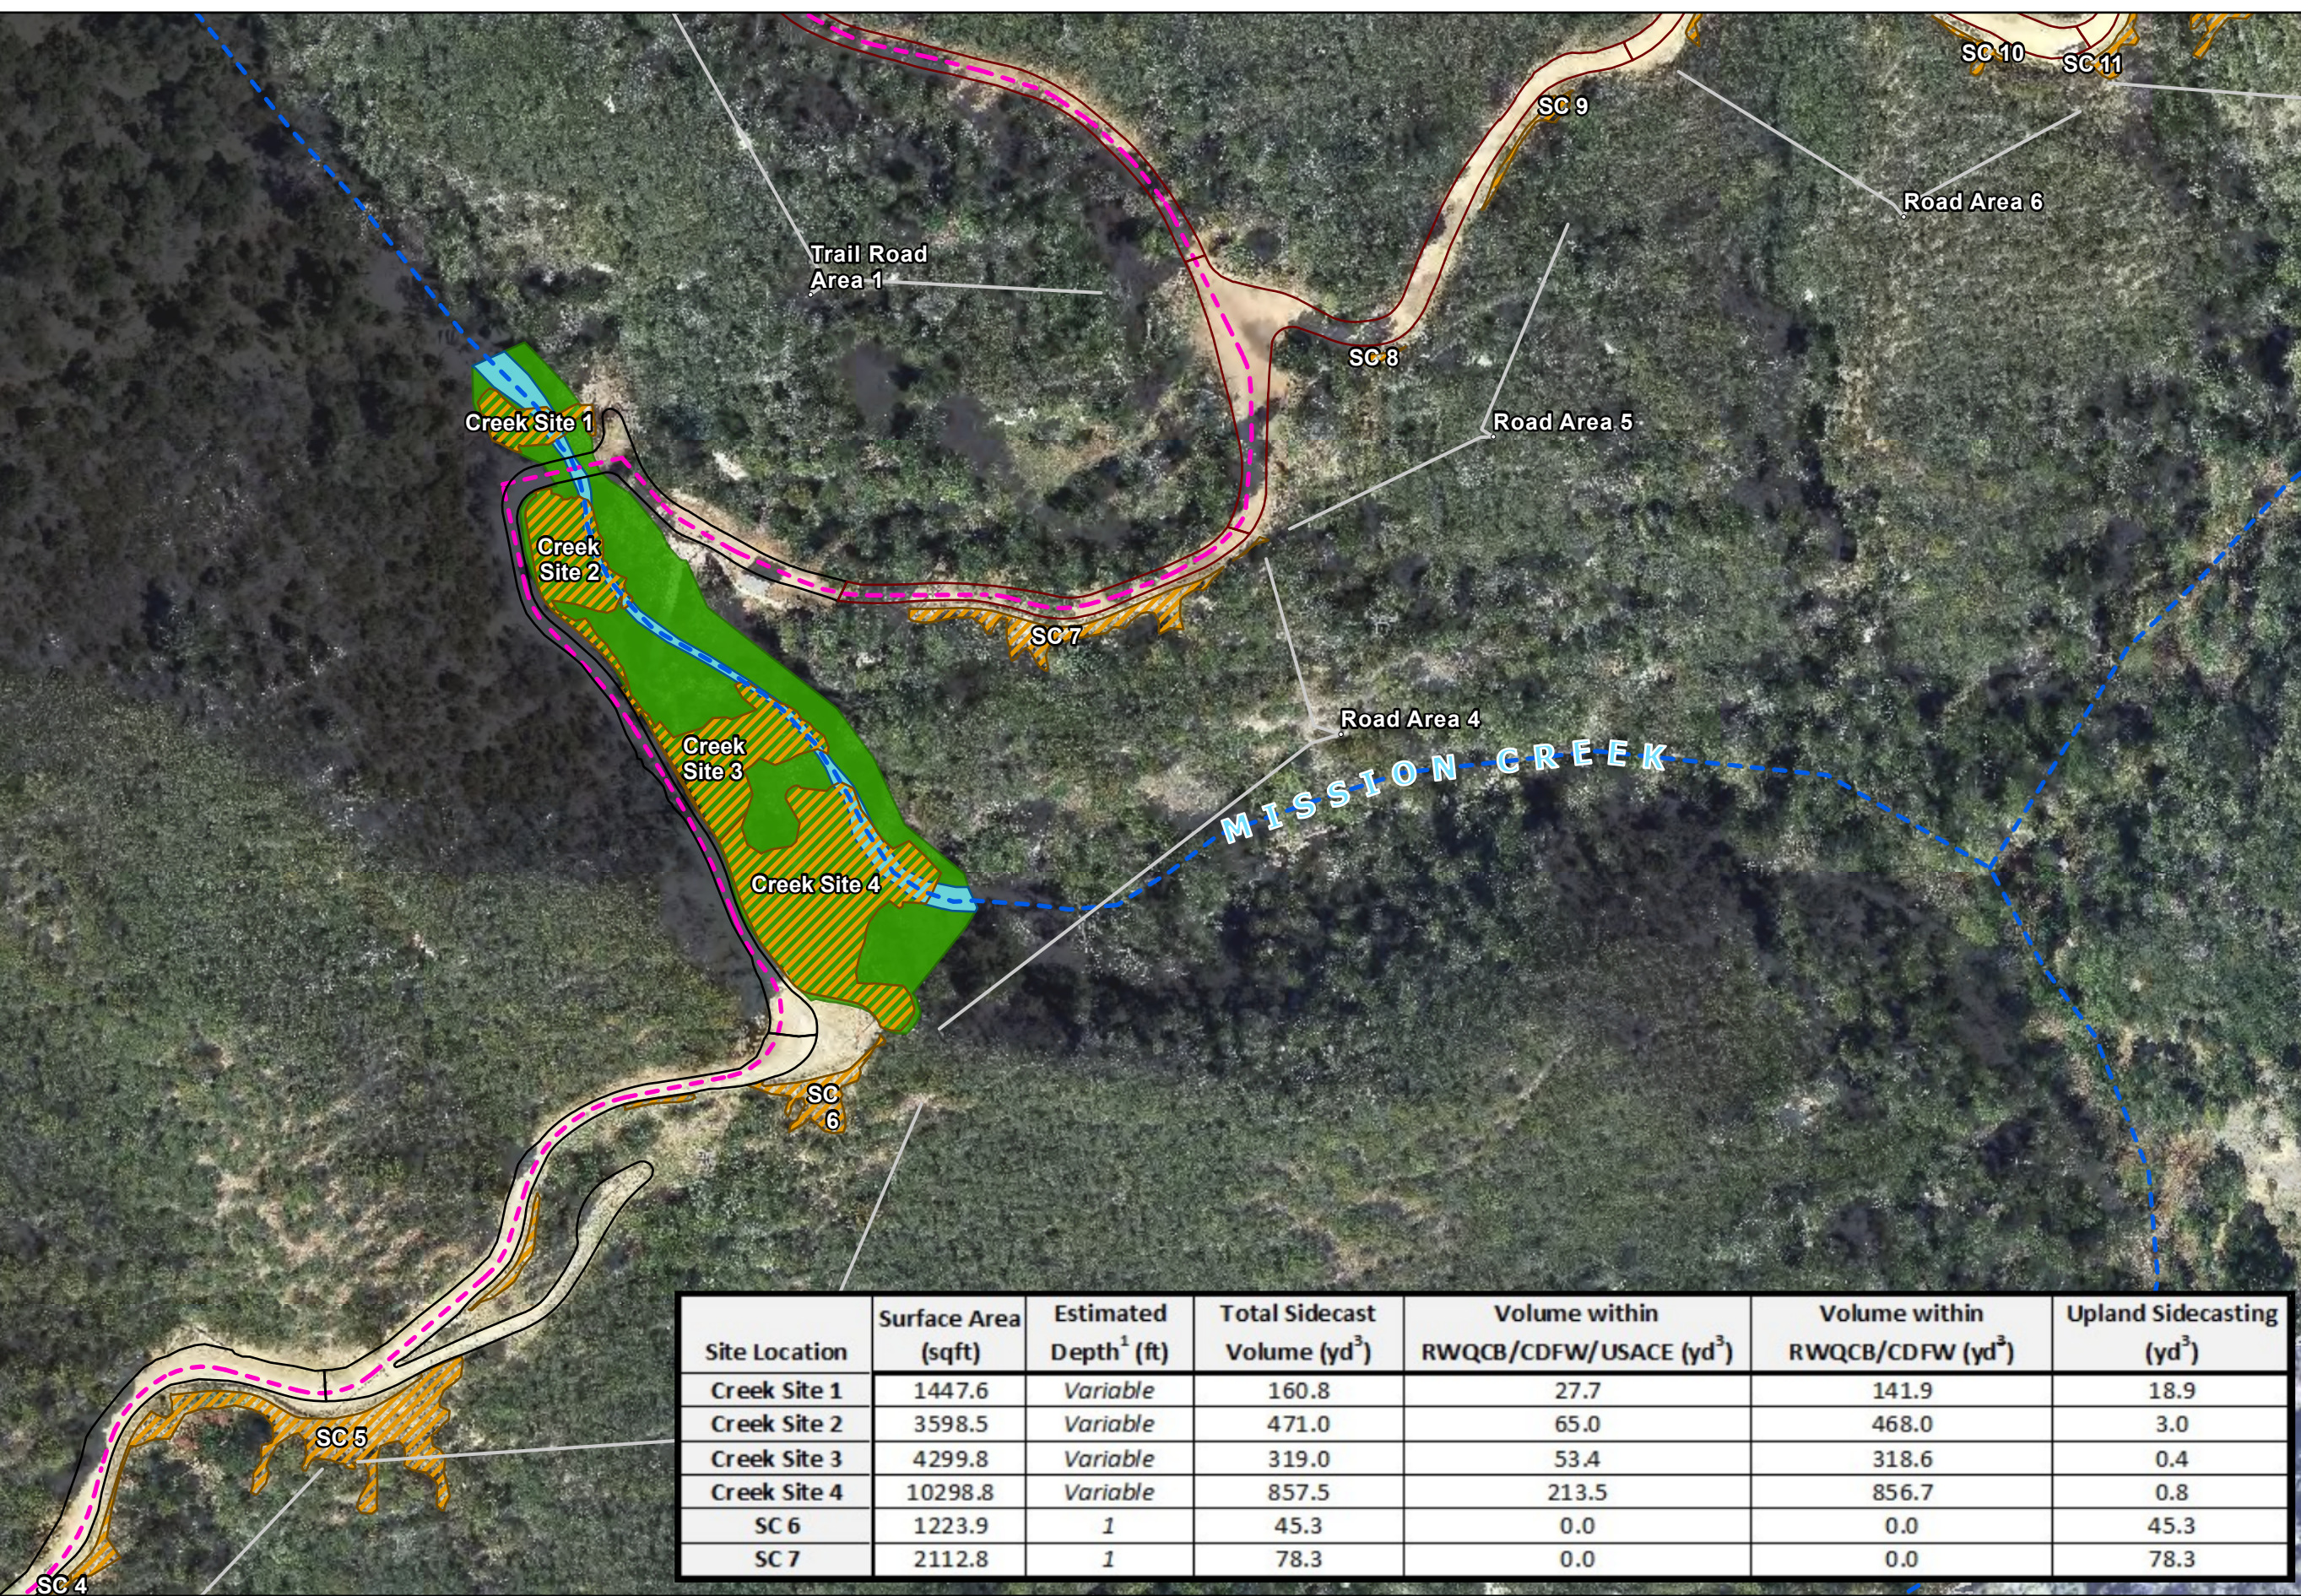
Site Location	Surface Area (sqft)	Estimated Depth ¹ (ft)	Total Sidecast Volume (yd ³)	Volume within RWQCB/CDFW/USACE (yd ³)	Volume within RWQCB/CDFW (yd ³)	Upland Sidecasting (yd ³)
Creek Site 1	1447.6	Variable	160.8	27.7	141.9	18.9
Creek Site 2	3598.5	Variable	471.0	65.0	468.0	3.0
Creek Site 3	4299.8	Variable	319.0	53.4	318.6	0.4
Creek Site 4	10298.8	Variable	857.5	213.5	856.7	0.8
SC 6	1223.9	1	45.3	0.0	0.0	45.3
SC 7	2112.8	1	78.3	0.0	0.0	78.3
