Attachment A

Photographs of Mission Creek
Sidecast Areas

Access Road Maintenance
Project- Tunnel Trail Area,
1/29/2020 and 1/31/2020

Sidecast Material – Volume Estimate,
Mission Creek Access Road,
5/7/2020

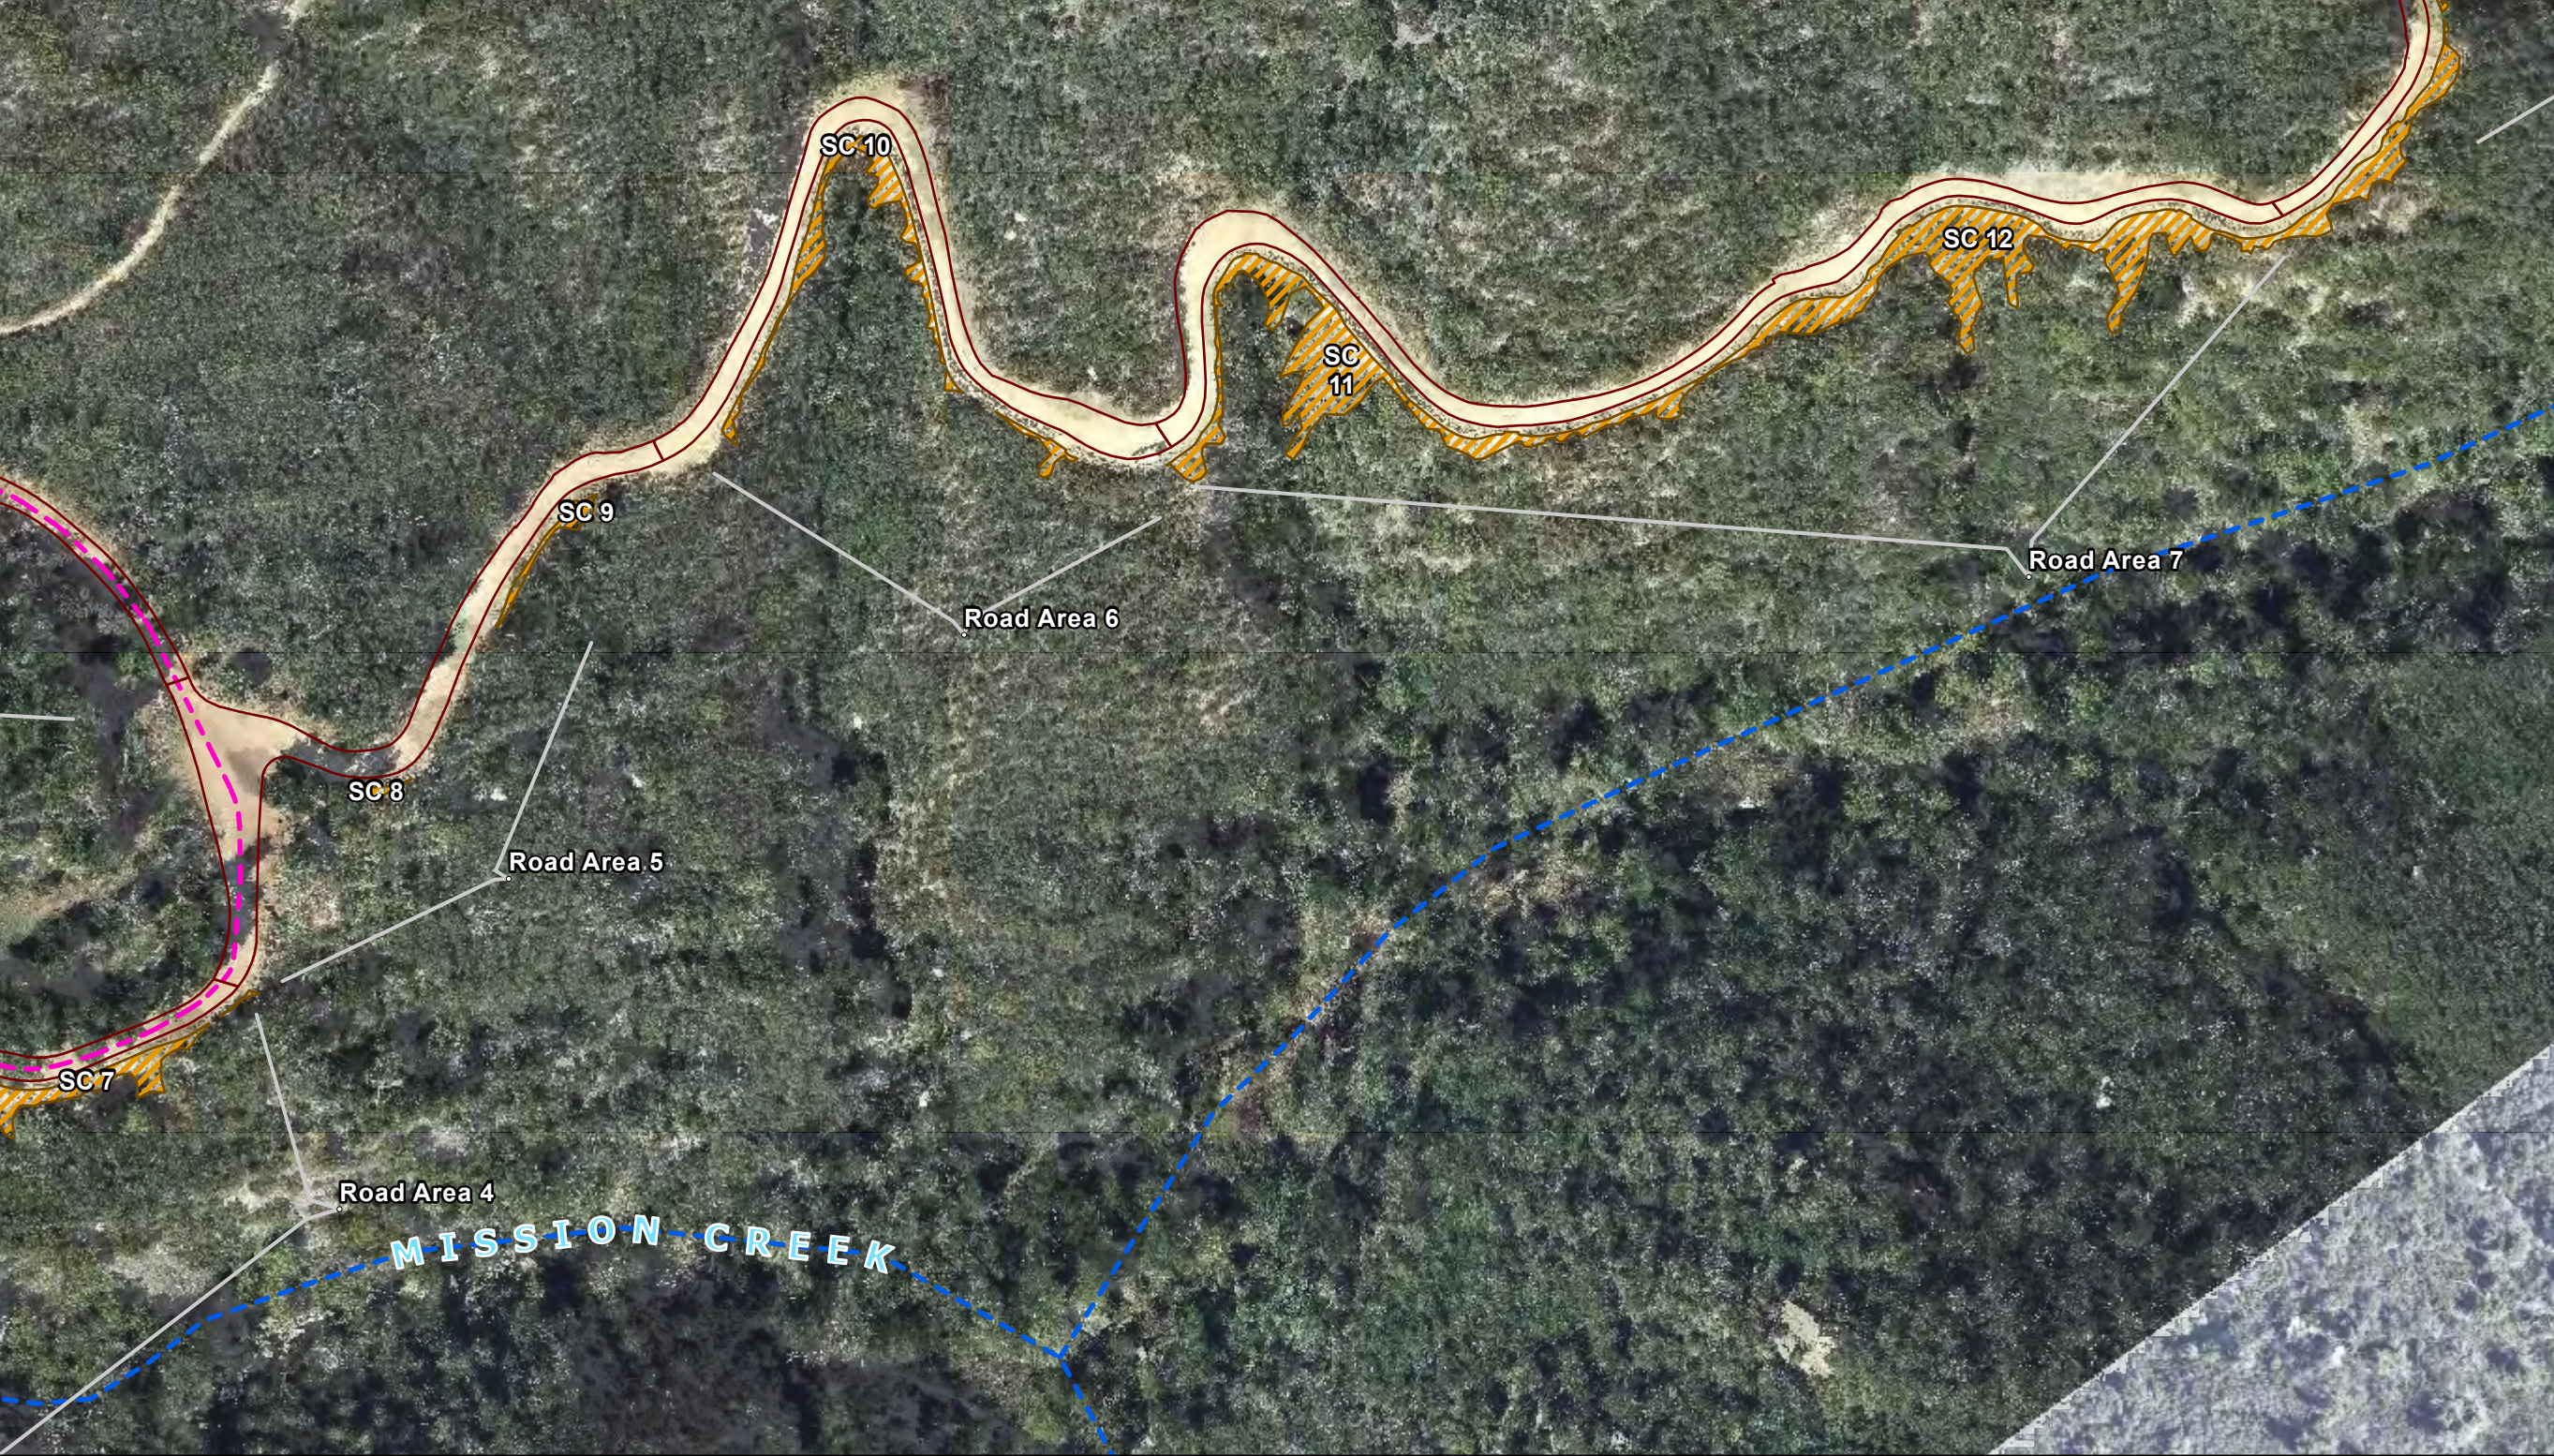
Site Location	Surface Area (sqft)	Estimated Depth ¹ (ft)	Total Sidecast Volume (yd ³)	Volume within RWQCB/CDFW/USACE (yd ³)	Volume within RWQCB/CDFW (yd ³)	Upland Sidecasting (yd ³)
SC 8	141.7	1	5.2	0.0	0.0	5.2
SC 9	414.7	1	15.4	0.0	0.0	15.4
SC 10	2036.1	1	75.4	0.0	0.0	75.4
SC 11	4891.5	1	181.2	0.0	0.0	181.2
SC 12	7424.7	1	275.0	0.0	0.0	275.0

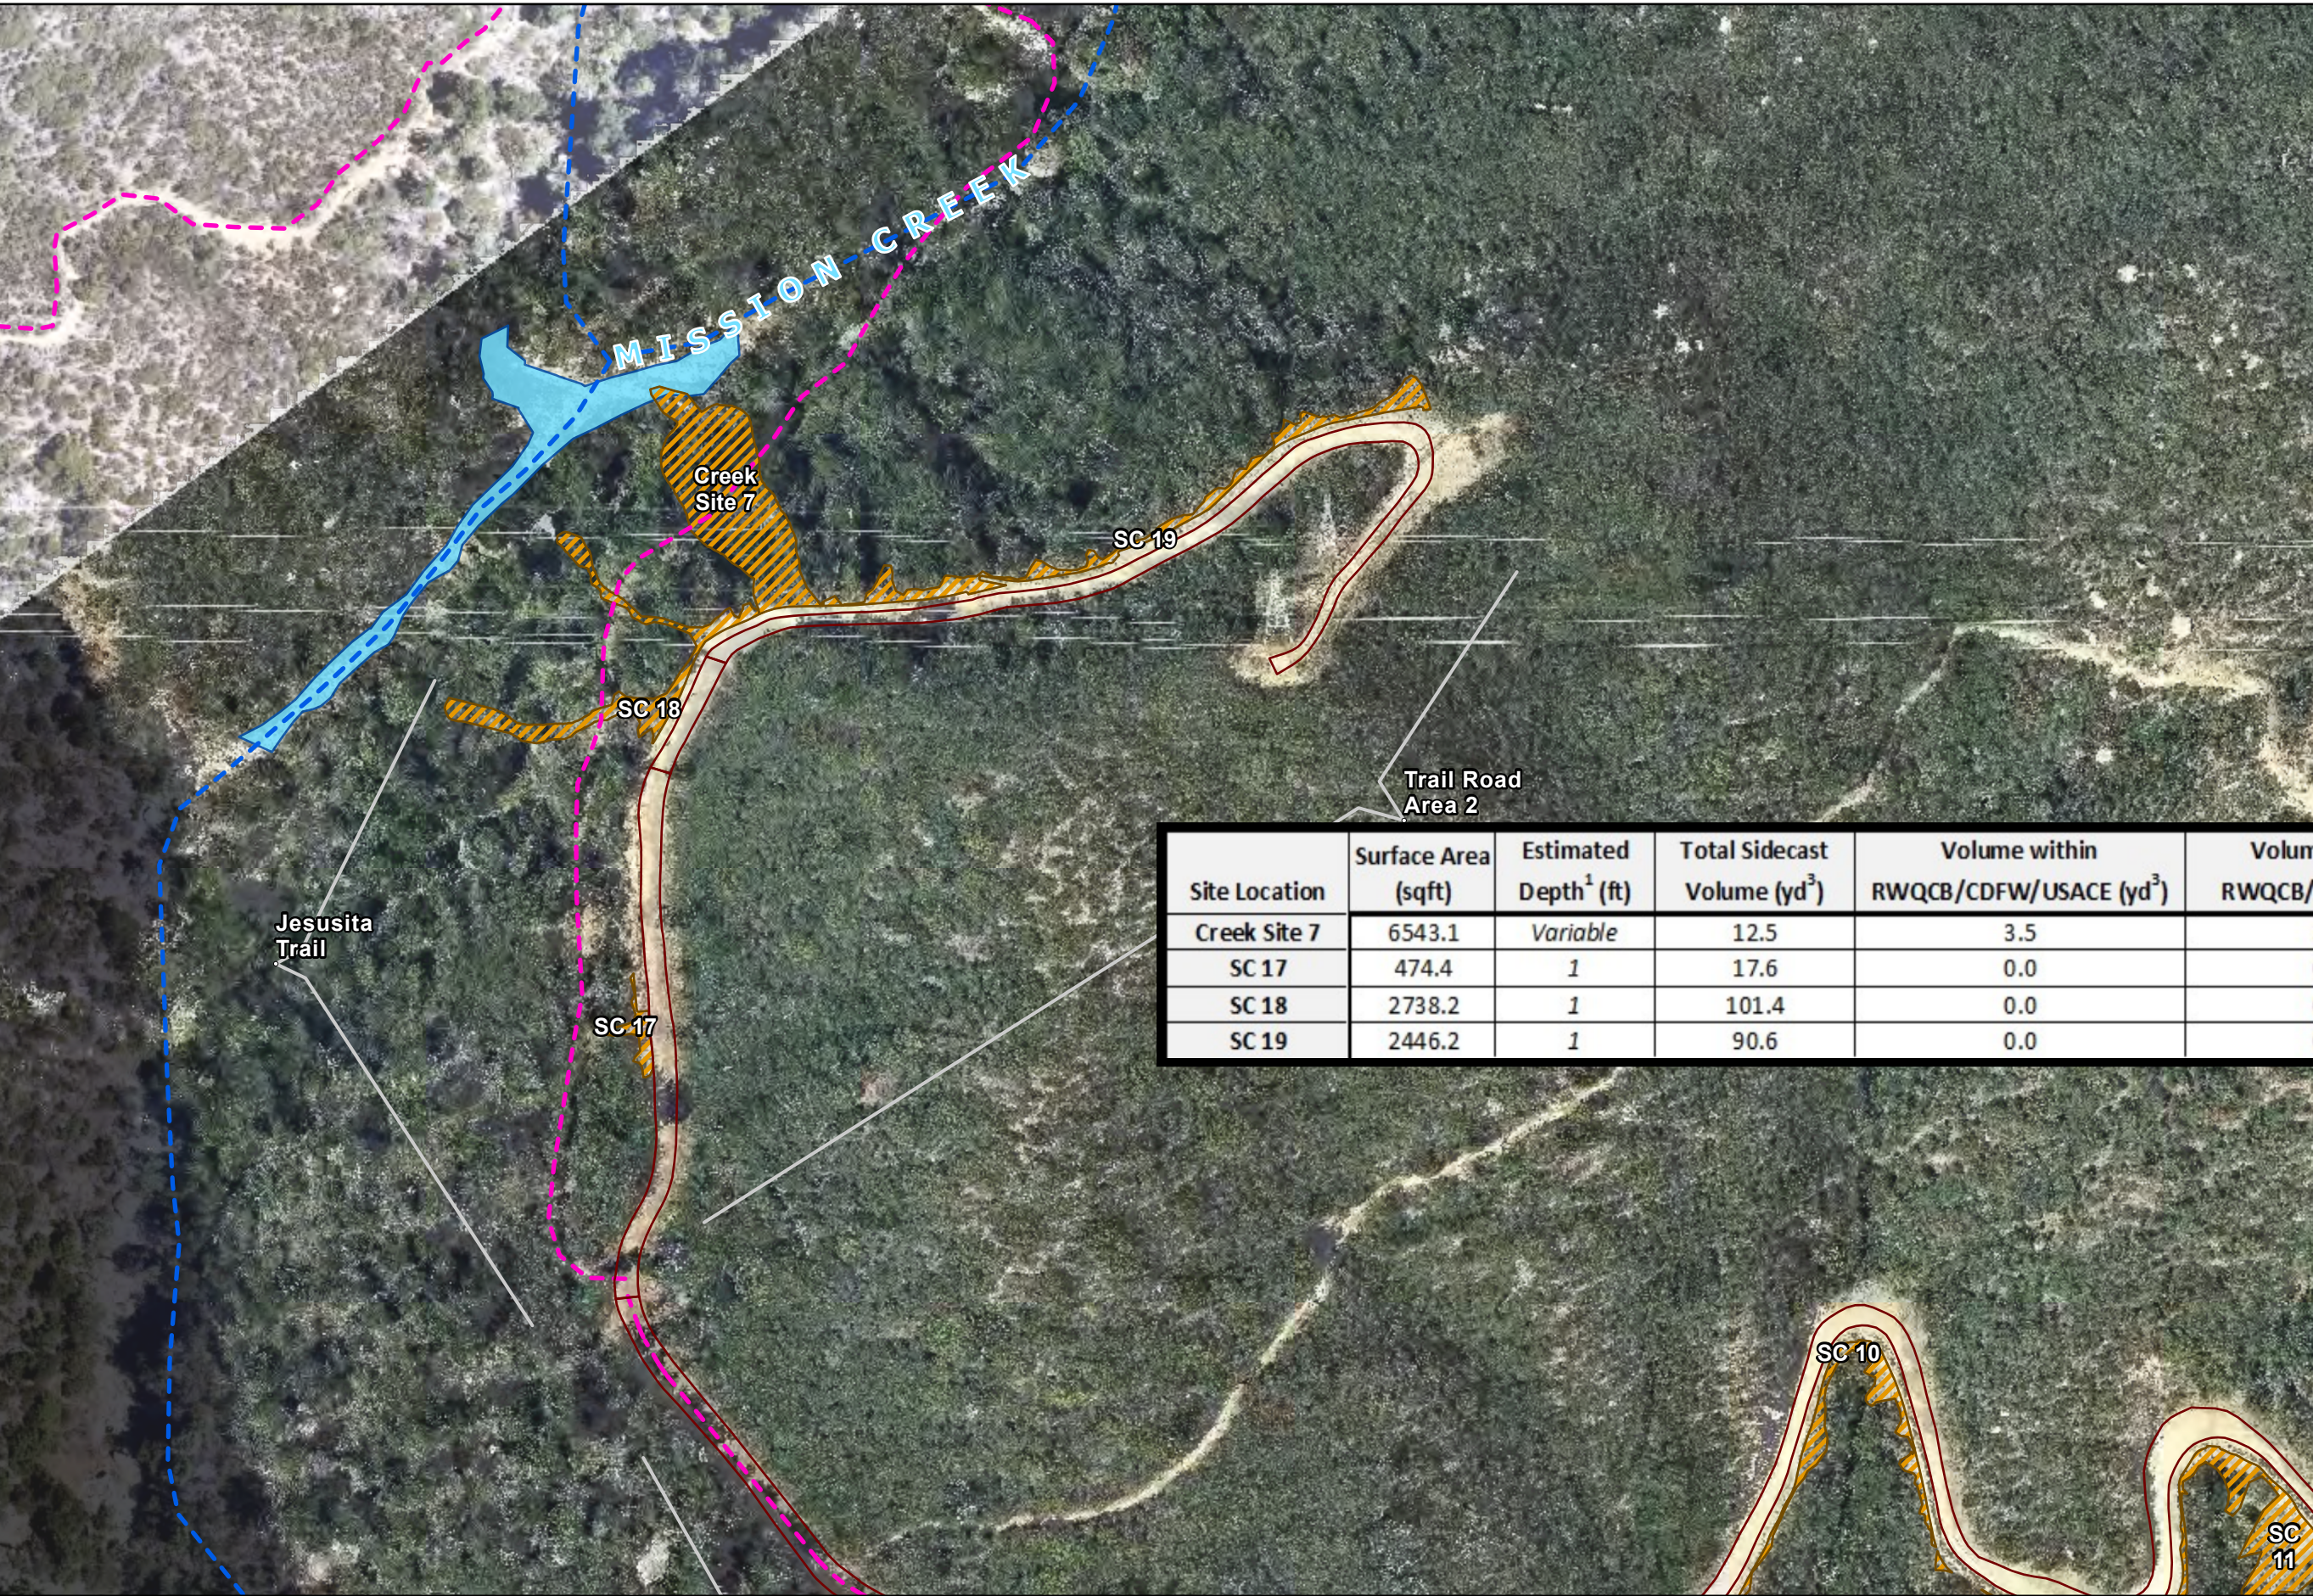
Site Location	Surface Area (sqft)	Estimated Depth ¹ (ft)	Total Sidecast Volume (yd ³)	Volume within RWQCB/CDFW/USACE (yd ³)	Volume within RWQCB/CDFW (yd ³)	Upland Sidecasting (yd ³)
Creek Site 7	6543.1	Variable	12.5	3.5	3.5	9.0
SC 17	474.4	1	17.6	0.0	0.0	17.6
SC 18	2738.2	1	101.4	0.0	0.0	101.4
SC 19	2446.2	1	90.6	0.0	0.0	90.6
