# Final Mission Creek Habitat Restoration and Mitigation Plan

February 2023 | 01606.00001.024 (EDS-01.10)

**Southern California Edison**

**HELIX Environmental Planning, Inc.**  
7578 El Cajon Boulevard  
La Mesa, CA 91942

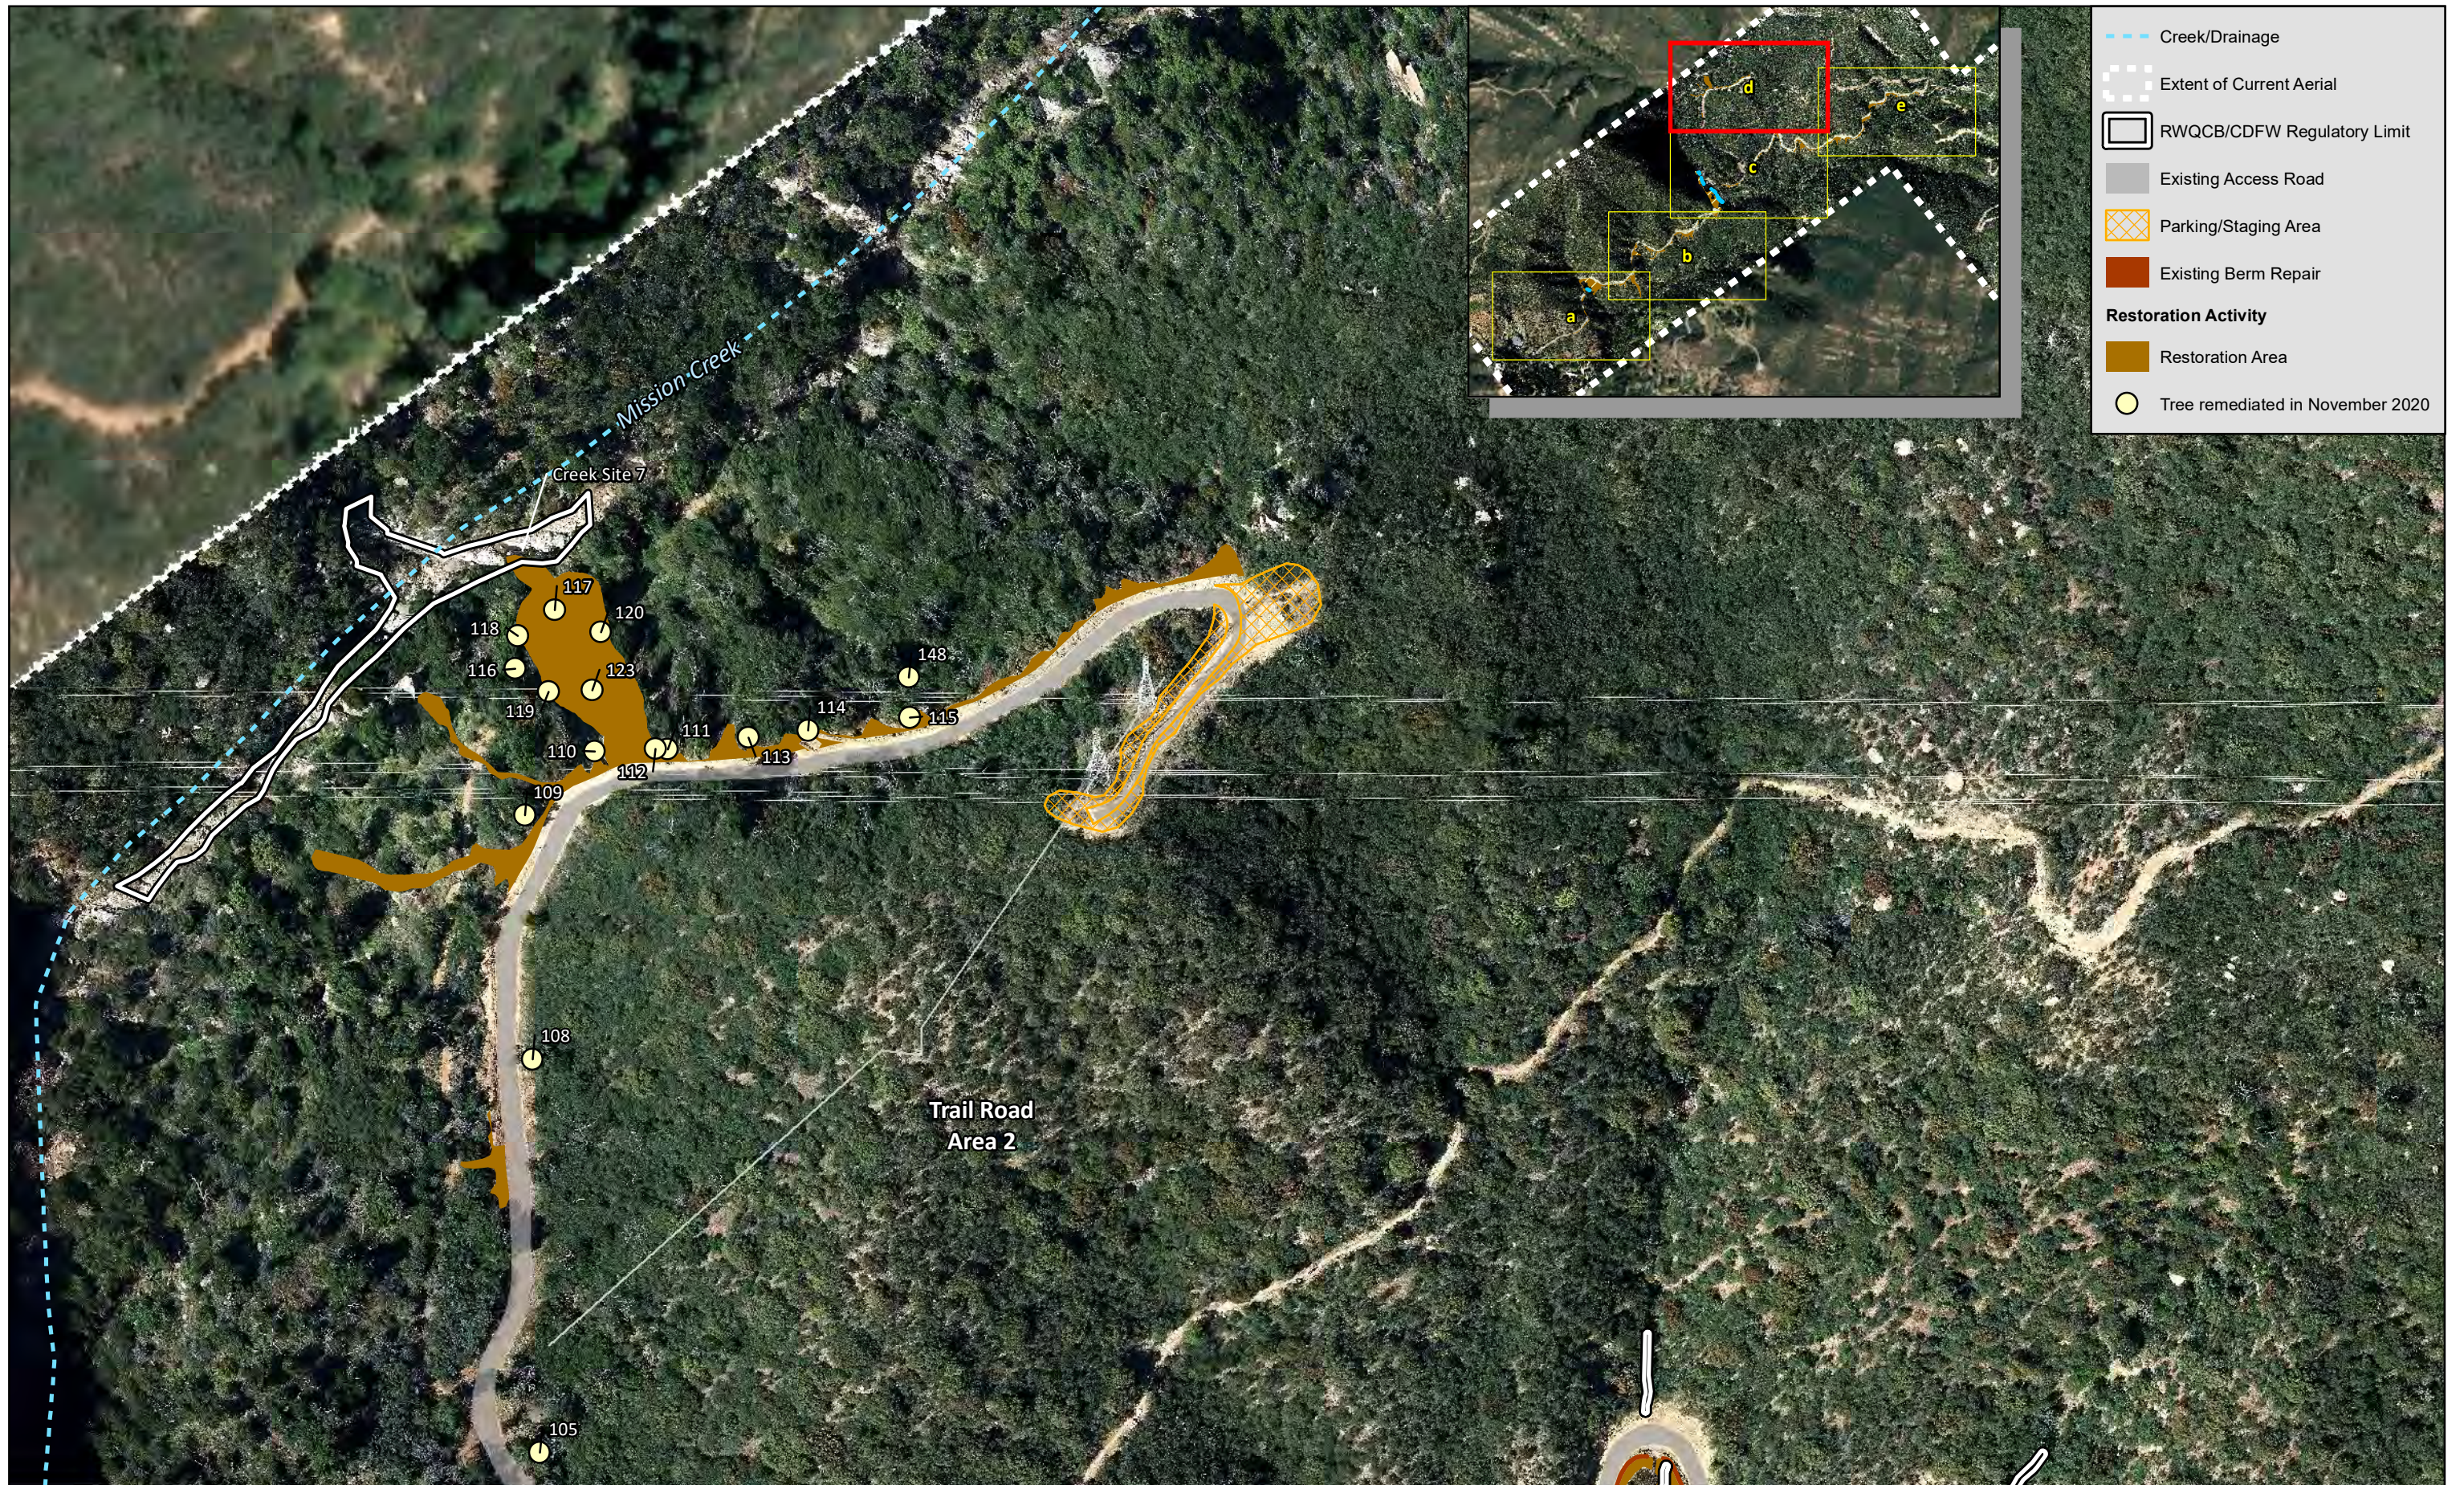
Figure 5d

- - - Creek/Drainage
- Extent of Current Aerial
- RWQCB/CDFW Regulatory Limit
- Existing Access Road
- Parking/Staging Area
- Existing Berm Repair
- Restoration Activity**
- Restoration Area
- Tree remediated in November 2020

The habitat restoration described in this plan is intended to consist of three main phases: restoration planning and preparation (Sections 4 and 5), installation (Section 6), and the maintenance monitoring program (Sections 7 and 8). Figures 5a-e show areas subject to revegetation activities described in this Creek HRMP. The following sections outline the Project strategy and approach to address each of the Project goals listed above.

Staging areas are needed to support Project activities, including but not limited to vehicle parking, equipment staging, or material processing and storage, etc. These areas, identified in Figures 5a-e, have been selected to coincide with existing road shoulders and pullouts or disturbed areas to eliminate impacts to native vegetation and trees. To minimize disturbance, SCE proposes to use staging areas previously approved for use for the Mission Canyon Road Repair Project in 2020. It is not anticipated that any staging area will require native brush removal or grading, and any non-native vegetation present will be removed prior to use.

The following prescriptions are for trees within Mission Creek’s USACE, CDFW, and RWQCB regulatory areas that will be remediated through the implementation of this Creek HRMP. Remedial measures have been proposed in conjunction with the Tree Impact Assessment Report (HELIX 2020b, HELIX 2020c, Figures 5a-e). During the time of the tree assessment, corrective measures were noted for each tree, which would aid in the recovery and/or survival of that individual. The categories used for this assessment and their approximate criteria are defined below:

The Project areas will be seeded using a two-stage hydroseed application method completed in consecutive steps. In stage 1, the seed mix (25 pounds per acre) will be mixed with approximately 500 pounds per acre of long-strand wood fiber, a colorant, 150 pounds per acre of binder increased as necessary according to slope, and sufficient water to allow the mix to be applied evenly over the revegetation area (Figures 5a-e). All hydroseeding mixing will be performed in a clean tank free from
